Field testing of substandard full scale RC buildings for seismic performance assessment: **Quasi-static tests**

M. Comert, C. Demir, A.O. Ates, E. Tore, O. Ozeren,
A. Moshfeghi, S. Khoshkholghi, K. Orakcal, A. Ilki

- **Project name:** Seismic performance assessment of existing buildings through full-scale tests
- **Aim:** To supply experimental data on seismic performances of structures of actual scale
- **Content:** Site tests on two full-scale sub-standard buildings
- **Supported by:** Istanbul Development Agency, Istanbul Technical University and sponsors
- **Duration:** 9 months + 3 months extension
- **Team:** 3 professors, 2 post-docs, 6 PhD candidates, 5 MSc students, 1 undergraduate student
- **Advisors:** 6 professors from Japan and Turkey
- **Budget:** Approximately 300 000 USD
- **Some figures:** 200 m³ concrete poured, 10 t steel bars for construction, 5.5 t steel for test setup

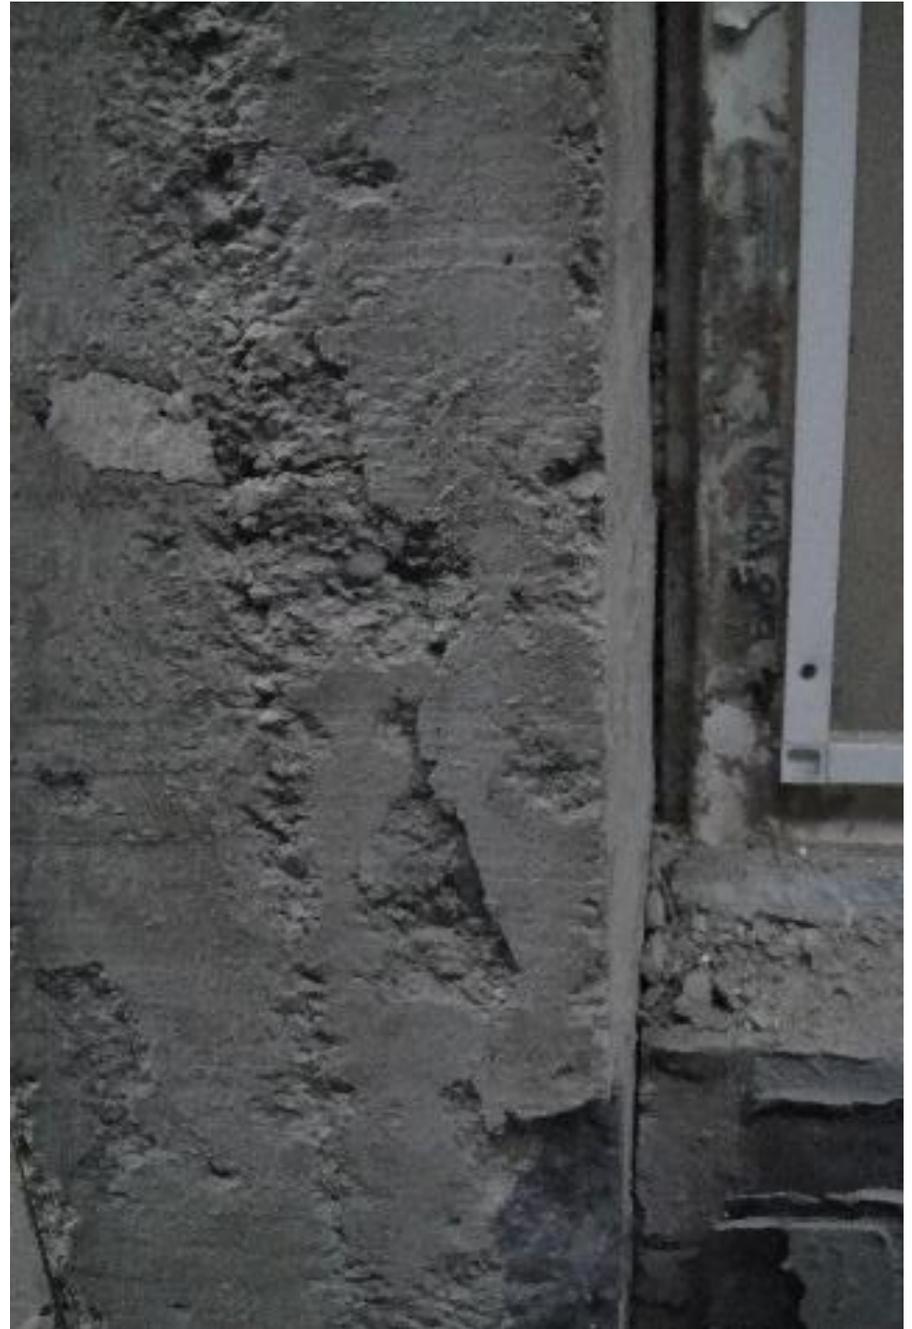
Low Concrete Quality

Before 2000's,
Most of buildings in
Turkey were constructed
with hand-mixed
concrete.

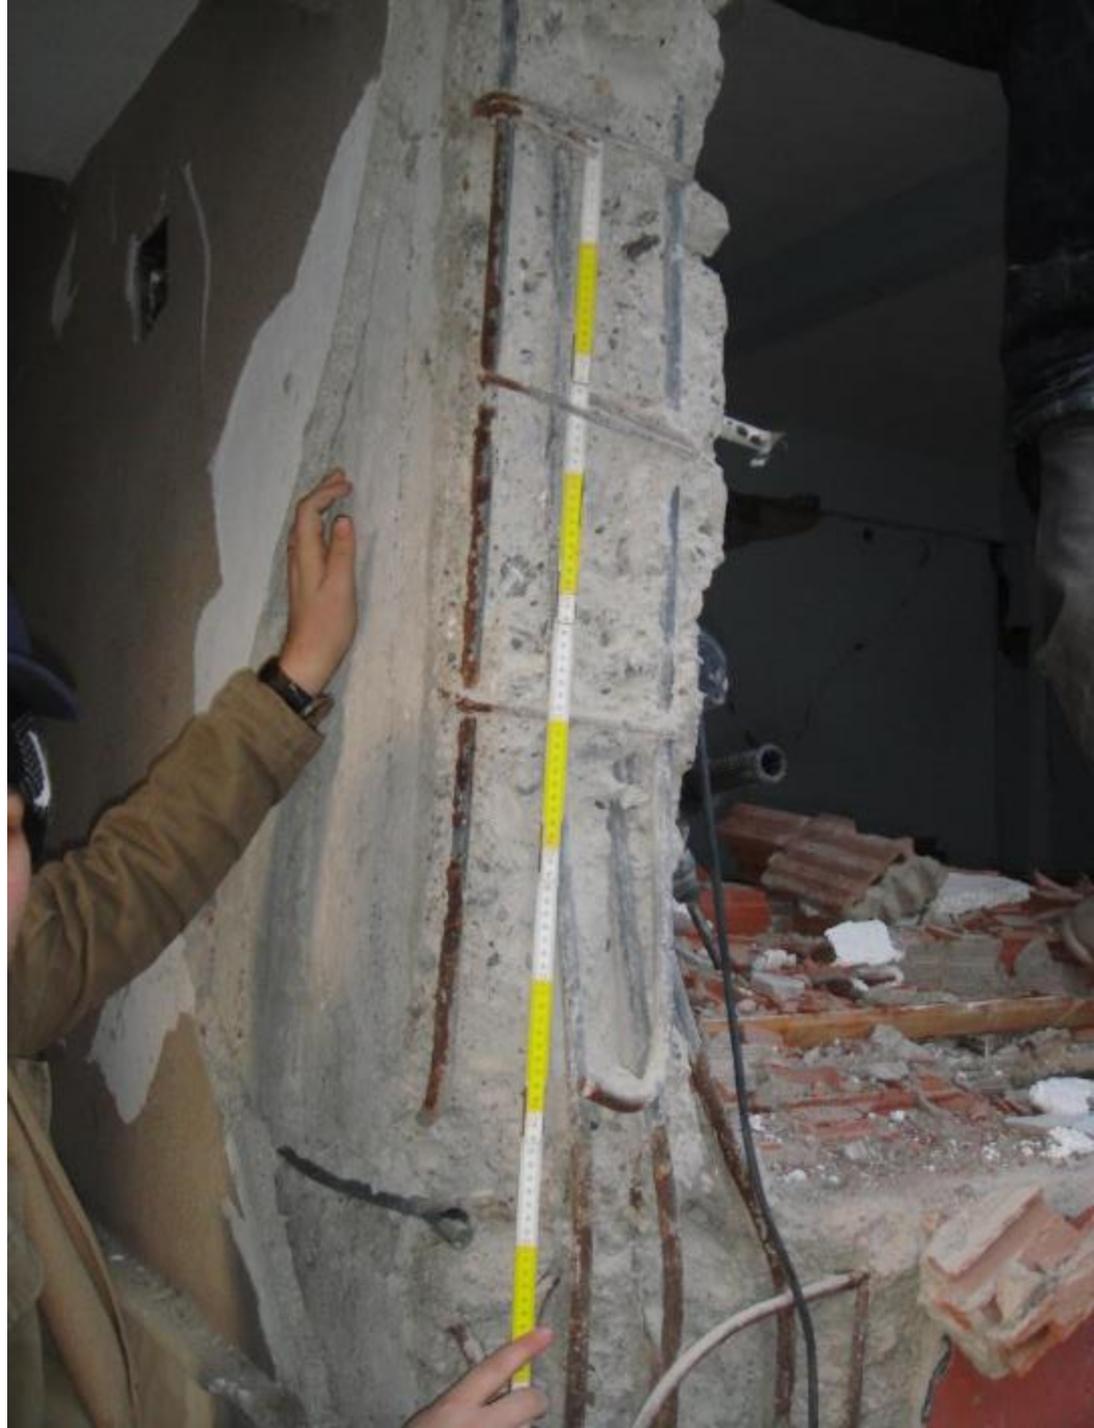
Large Stirrup Spacing

Approximately
200-300 mm

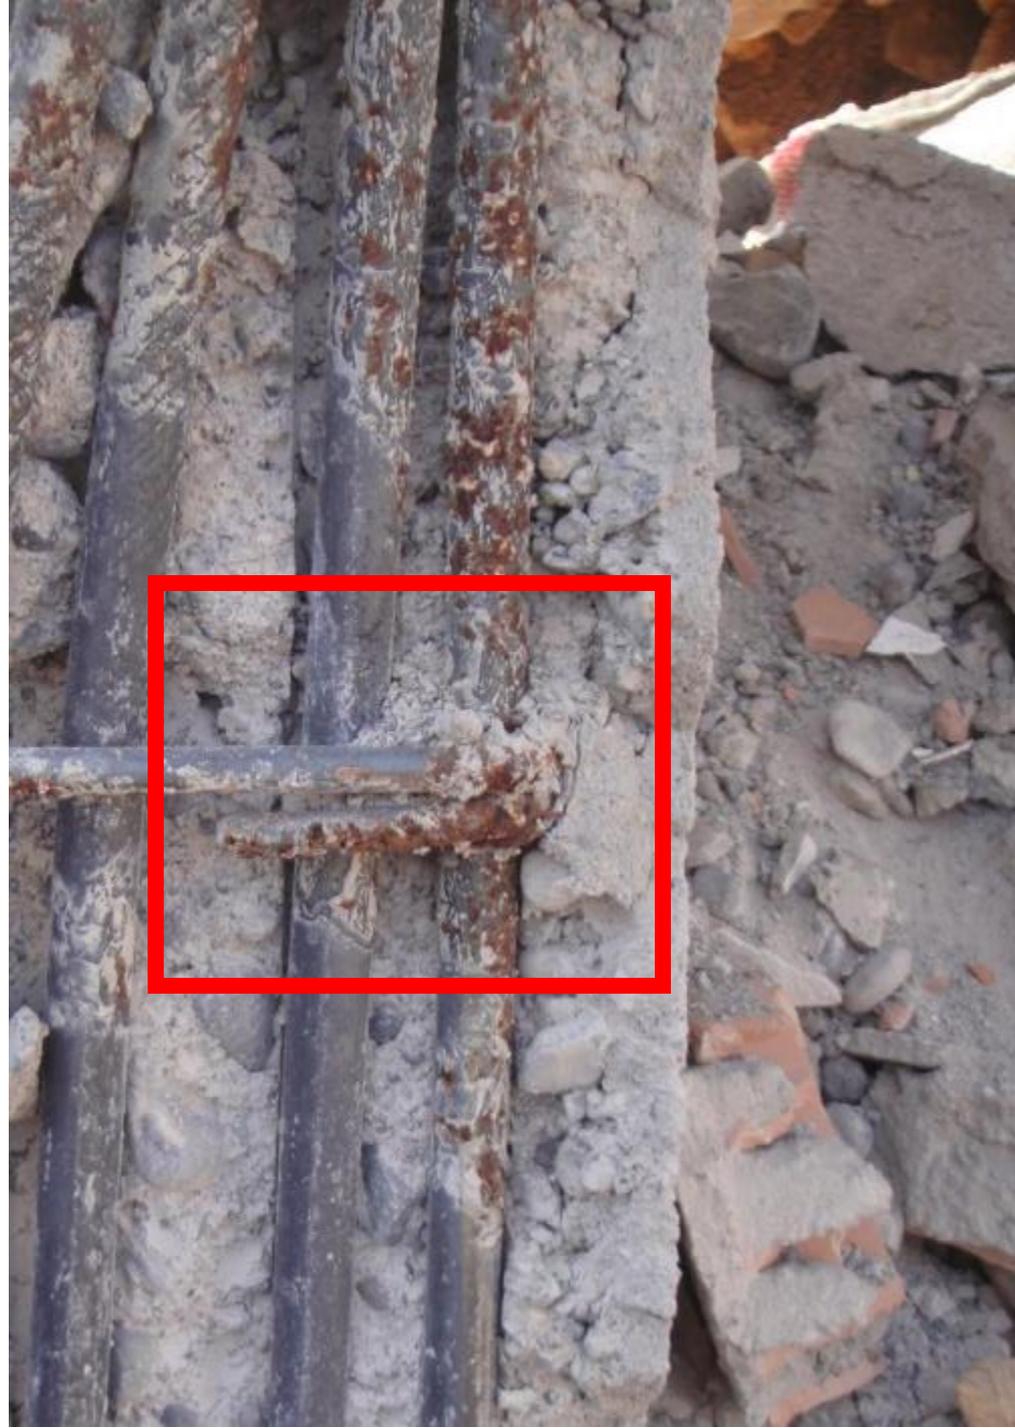
Improper Stirrup Hook Details

90° Hooks
and
Inadequate Hook
Length

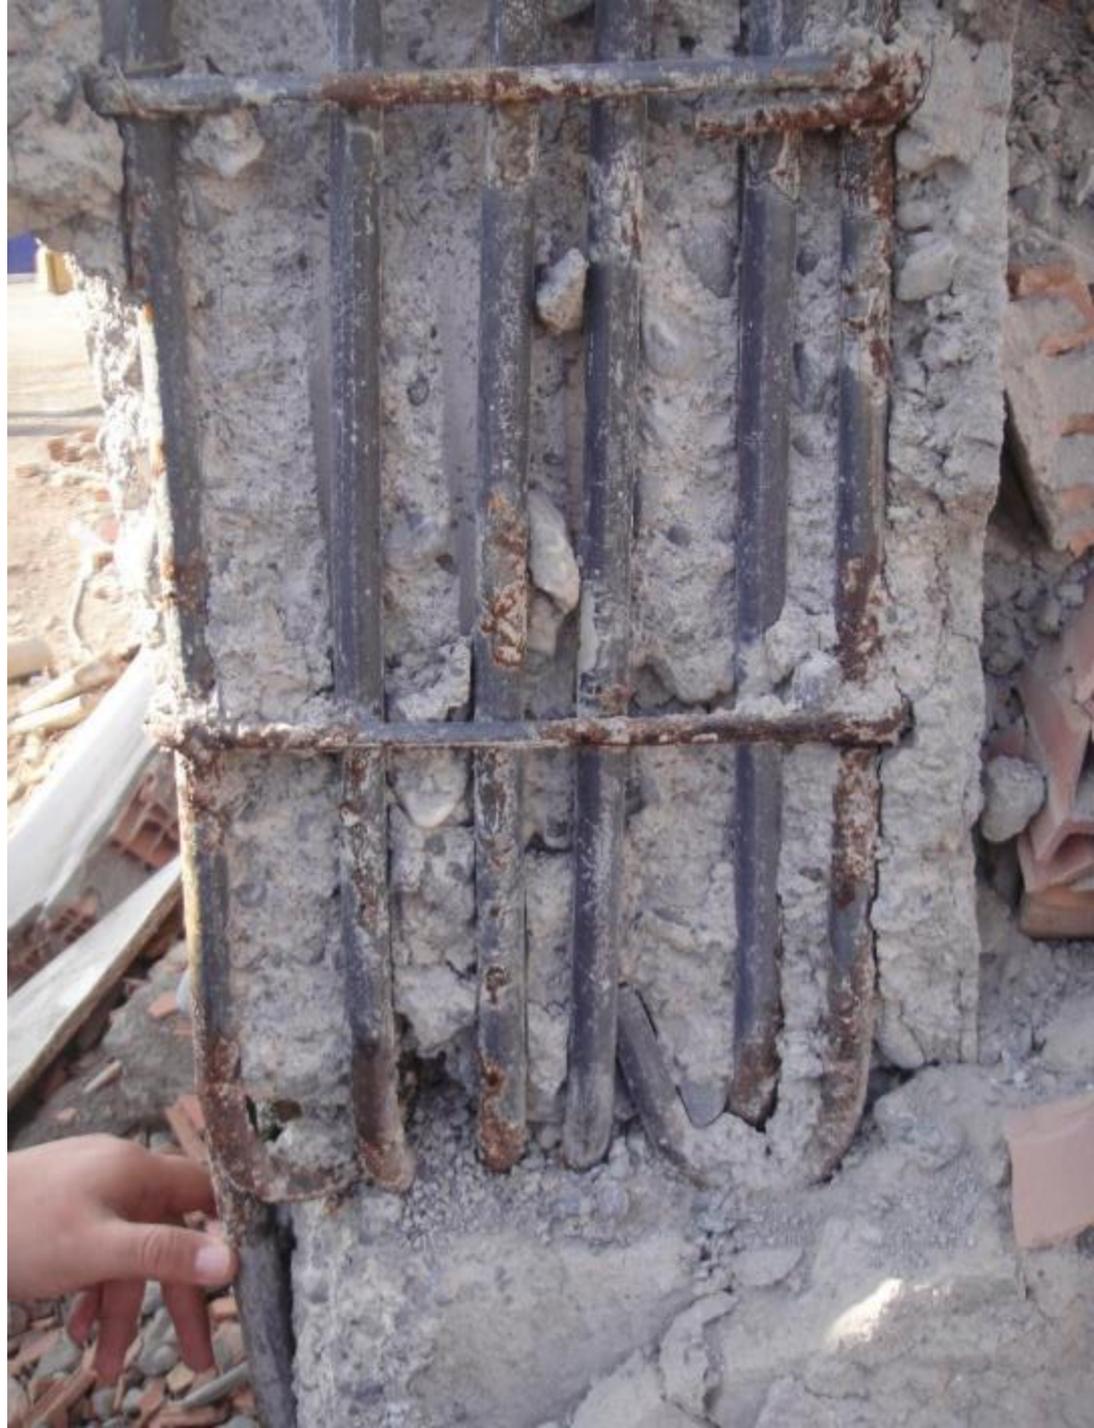
Plain Bars

Plain bars,
inadequate lap splice
lengths, missing
hooks

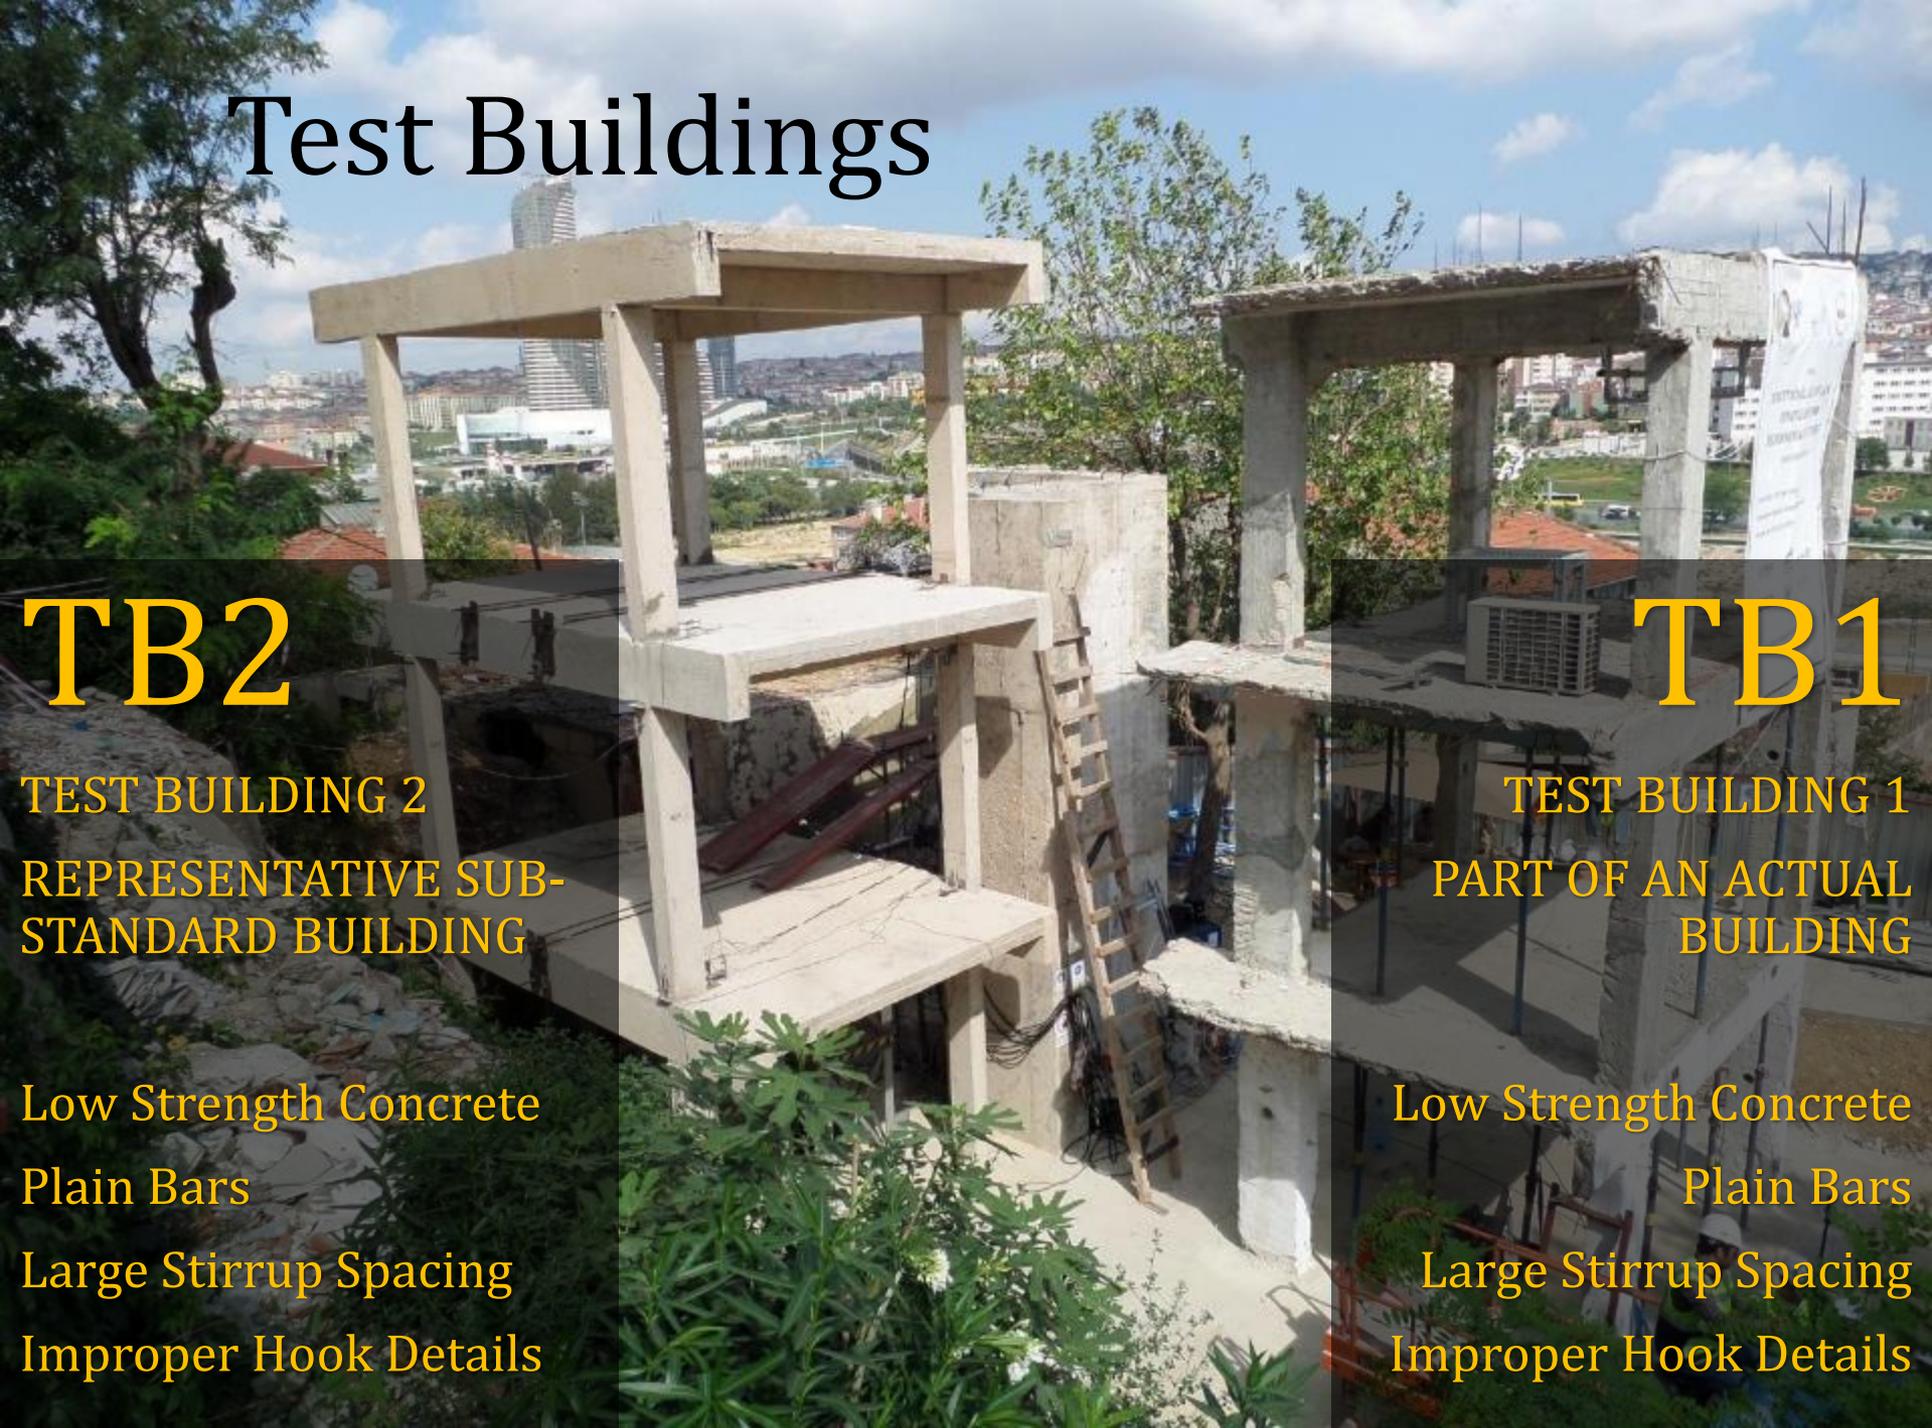
TEST BUILDING 2
REPRESENTATIVE SUB-
STANDARD BUILDING

Low Strength Concrete
Plain Bars
Large Stirrup Spacing
Improper Hook Details

TEST BUILDING 1
PART OF AN ACTUAL
BUILDING

TB1;

- Weak Beam – Strong Column
- Lower Axial Load Level
- Higher Shear Demand Capacity Ratio

TB2;

- Strong Beam – Weak Column
- Higher Axial Load Level
- Lower Shear Demand Capacity Ratio

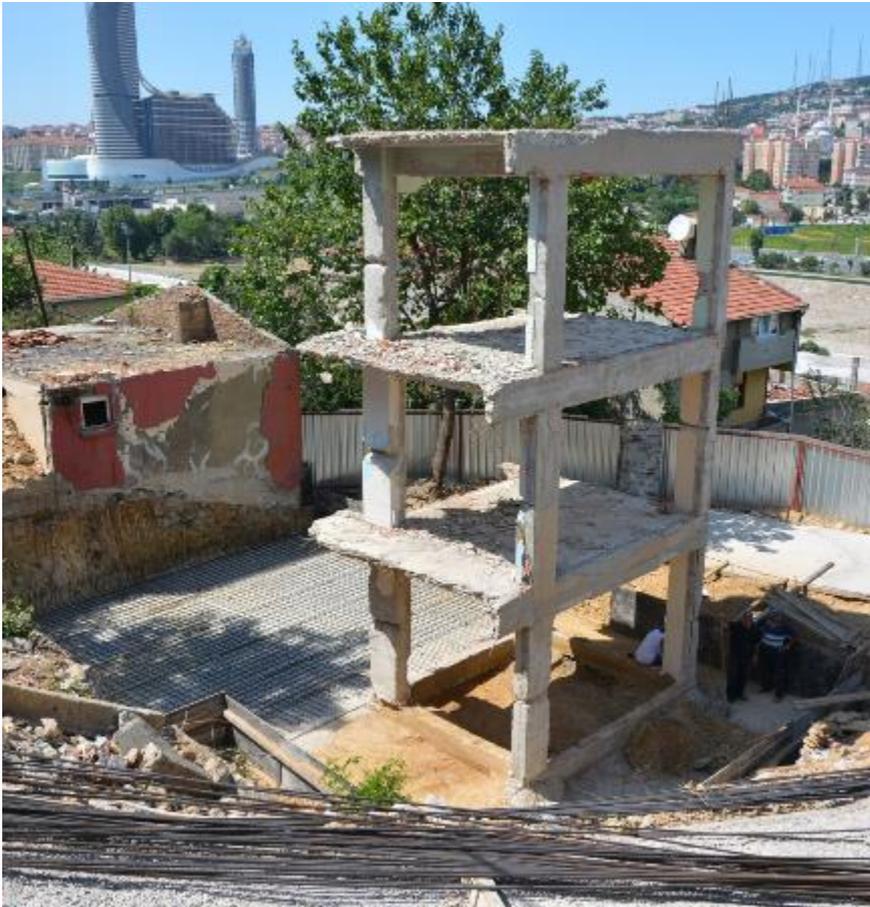
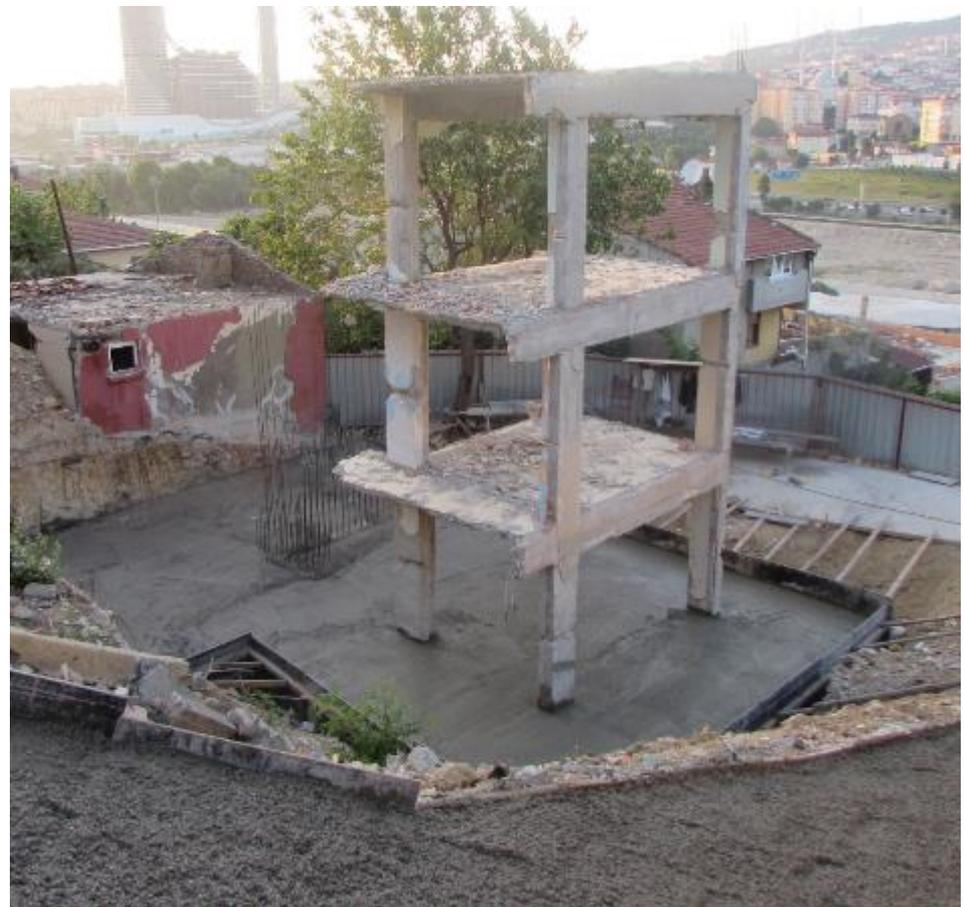
- Foundation construction
- 60 cm thick

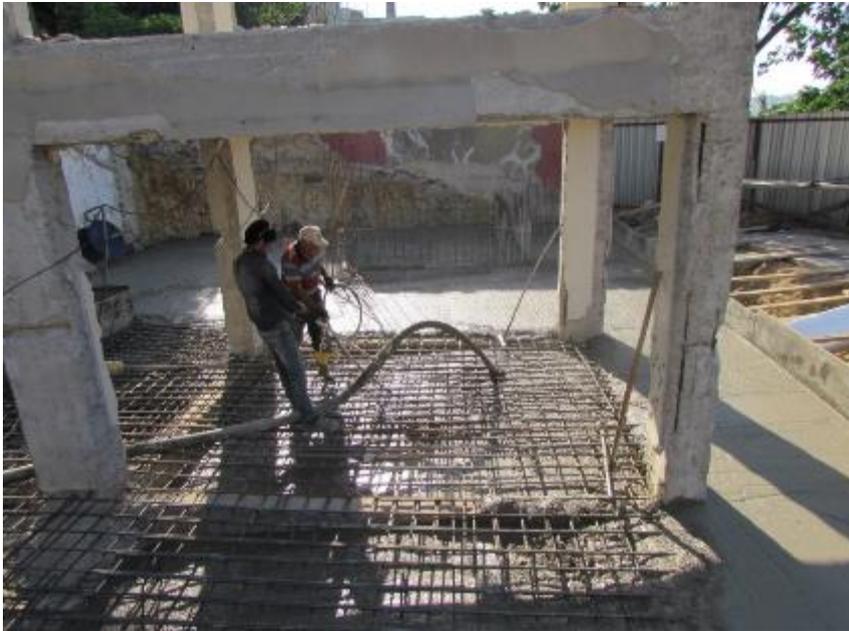
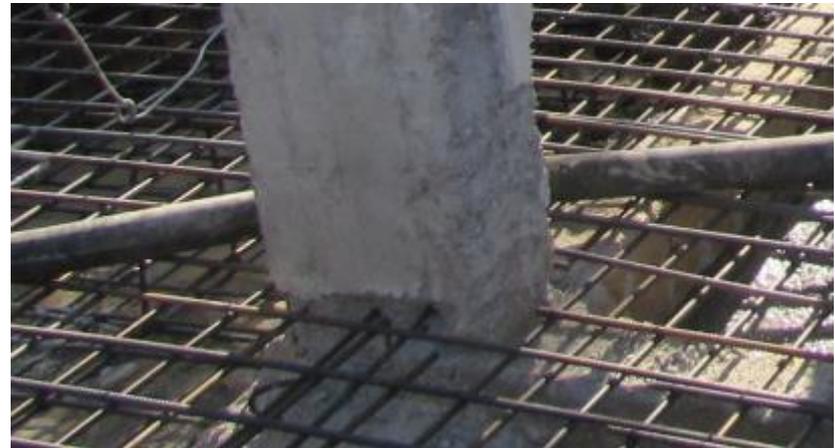
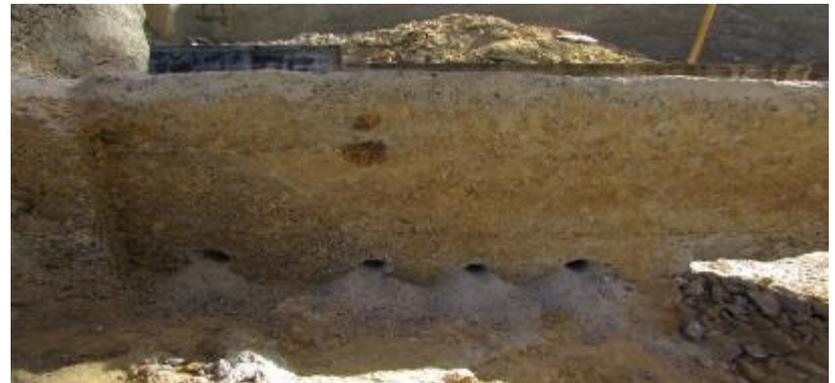
- New mat foundation for TB 1

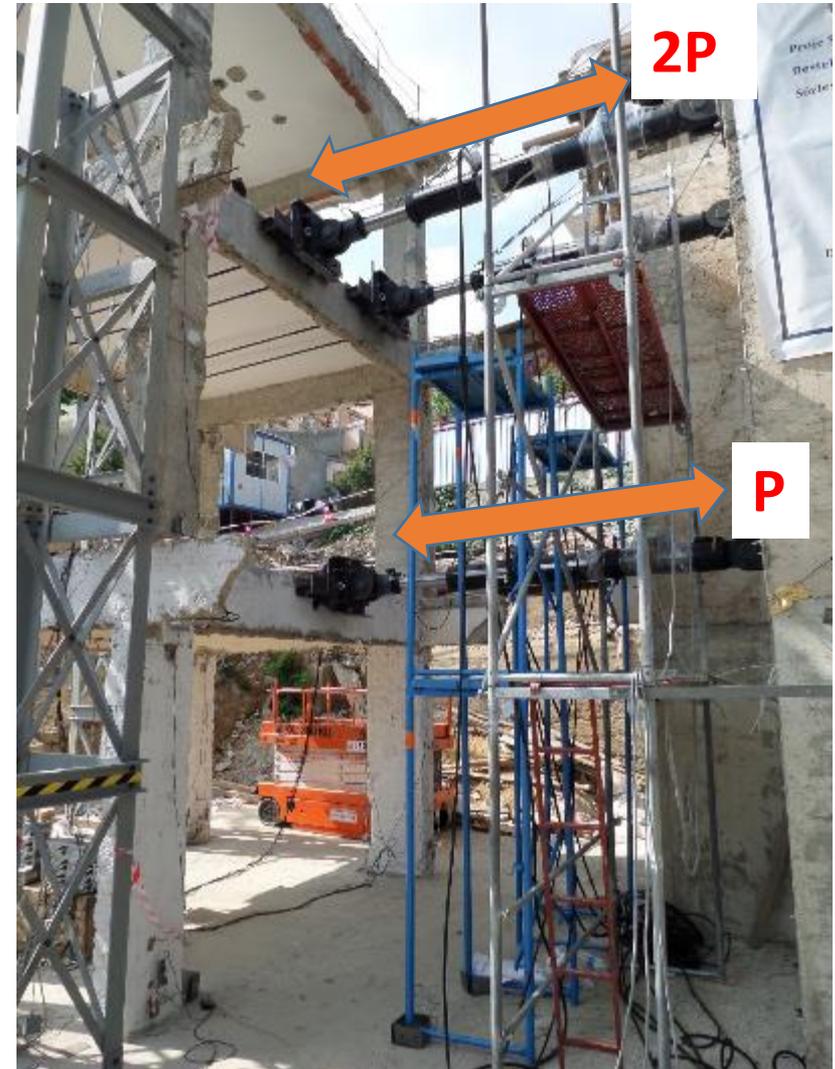
- Reversed cyclic loading with three hydraulic actuators (300 kN load and 800 mm displacement capacities)
- Displacement controlled loading for TB1
- Displacement and load controlled loading for TB2
- Load distribution in elevation(2P-P) kept constant

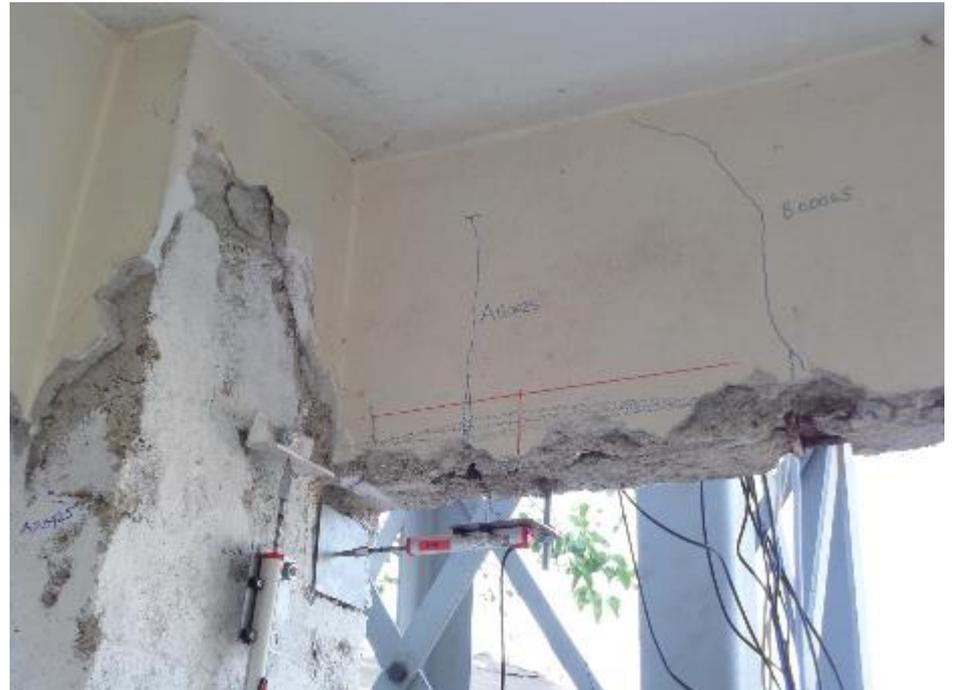
% 0.25 Drift Ratio – 1 cycle

Beams

$W_{\max} = 0.2 \text{ mm}$

Columns

$W_{\max} < 0.1 \text{ mm}$

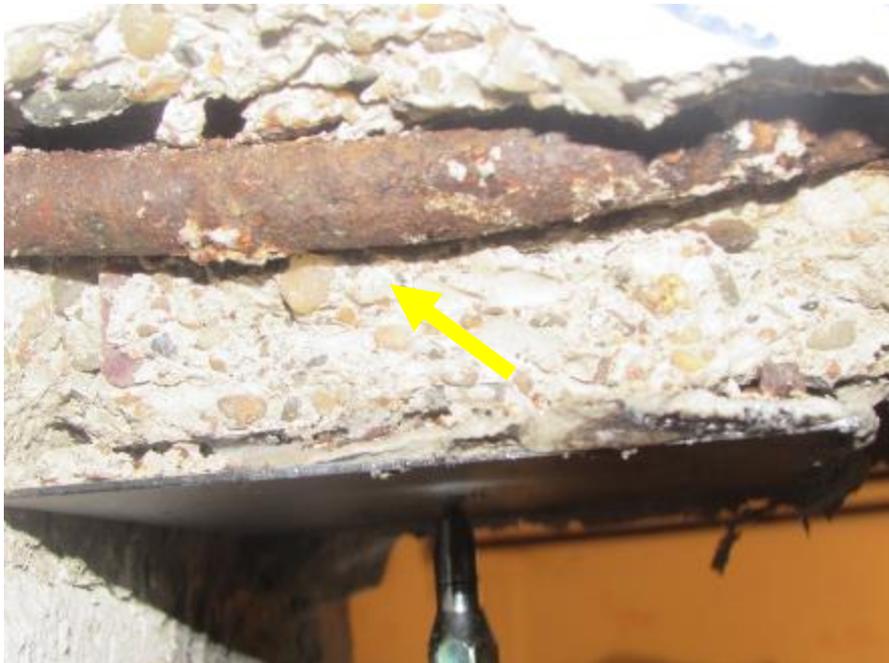
% 1.00 Drift Ratio - 2 cycles

$W_{\max} = 6 \text{ mm}$

Buckling of bars (K12)

$W_{\max} = 1.8 \text{ mm}$

Vertical Cracks

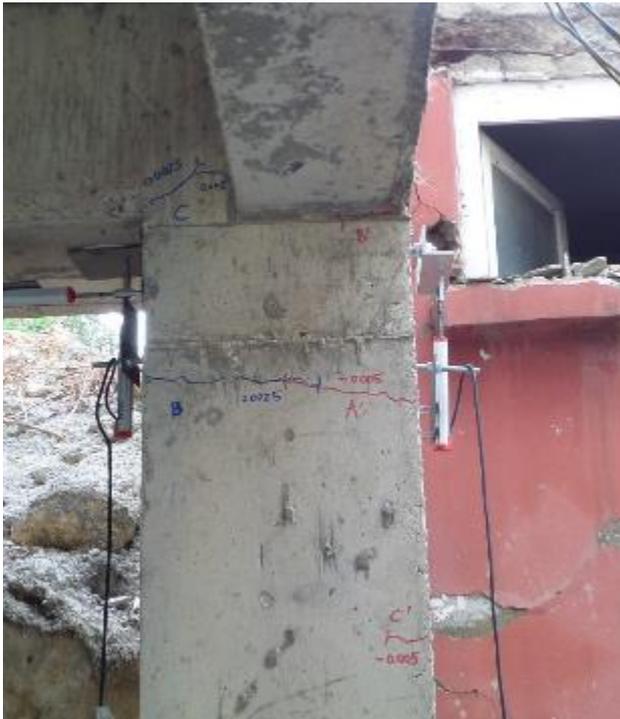
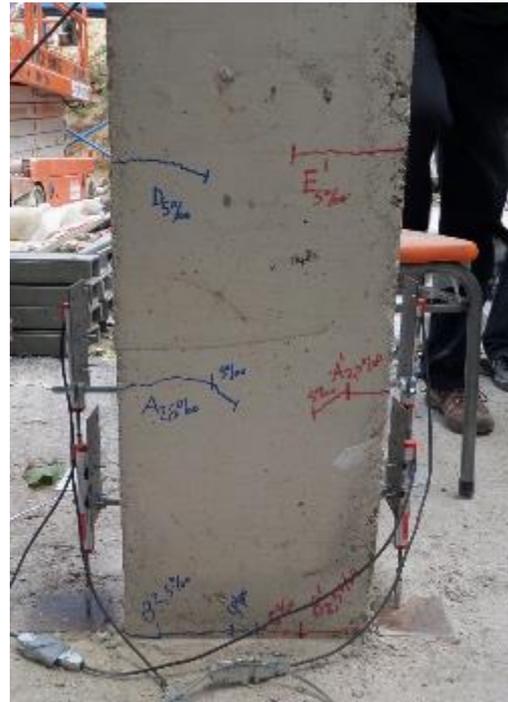
% 0.50 Drift Ratio – 2cycle

Beams
No damage

Columns
 $W_{\max} = 0.3 \text{ mm}$

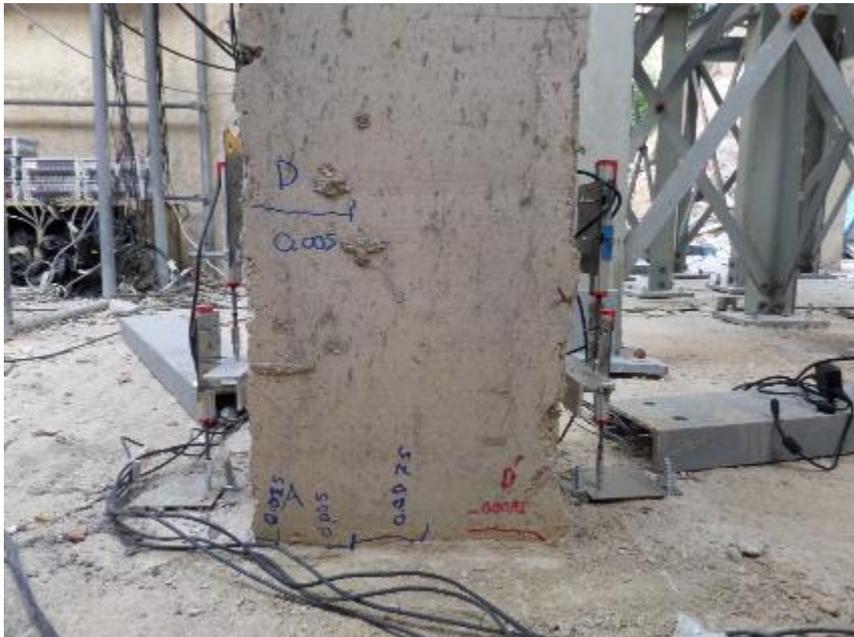
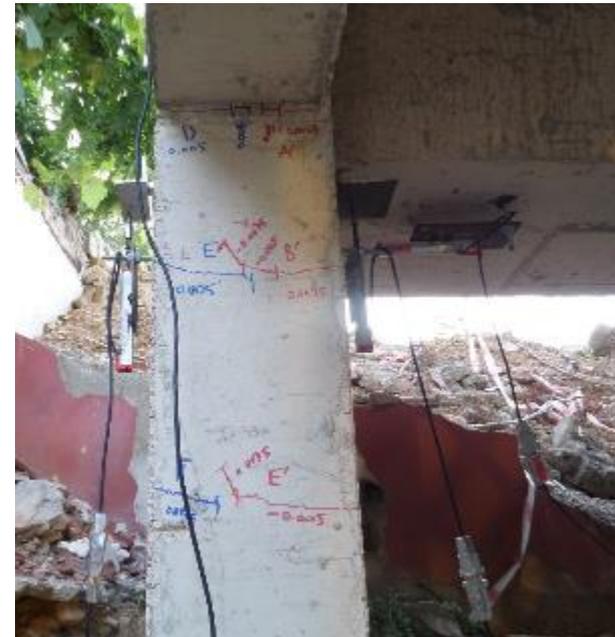
% 0.75 Drift Ratio – 1 cycle

Beams
No damage

Columns
 $W_{\max} = 1.4 \text{ mm}$

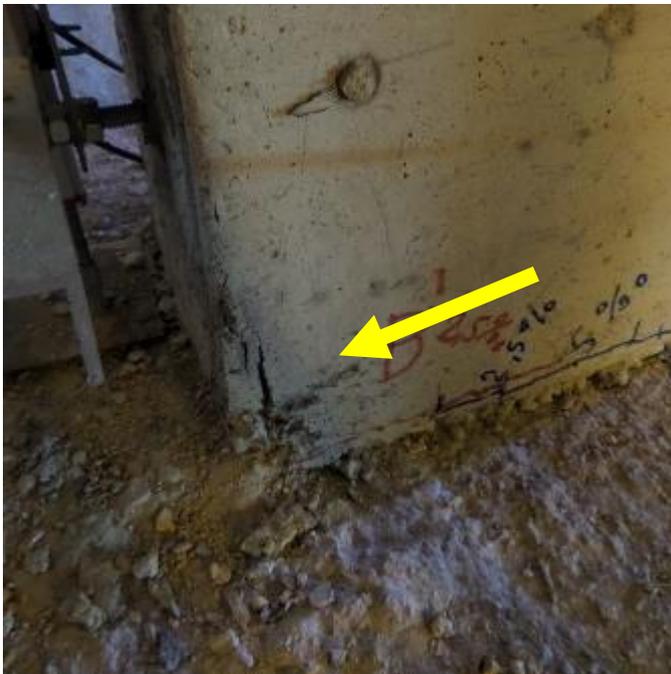
% 3.00 Drift Ratio – 2cycle

$W_{\max} = 8 \text{ mm}$

Concrete Cover Spalling

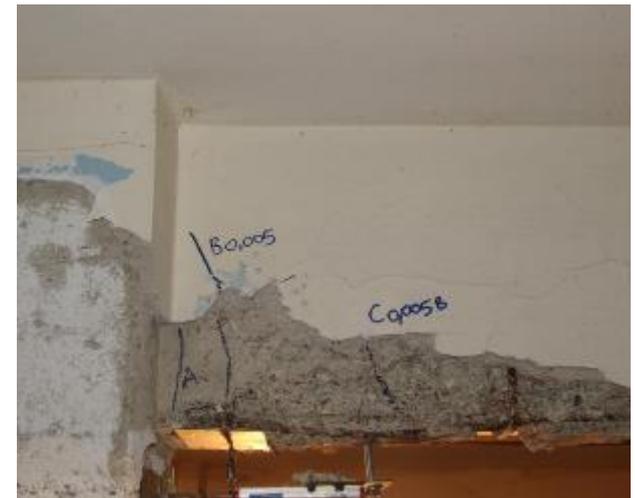
Beams

Drift Ratio (%)	Crack Width at Peak (mm)	Residual Crack Width (mm)
0.25	0.2	0.1
0.50	2.2	0.6
0.75	1.8	1.2
1.00	6.0	5.0
1.50	9.0	6.0
