**Workshop on "Determination of the Seismic Performance of the Existing Buildings by Full Scale Tests" October 20<sup>nd</sup>, 2014, Istanbul – ISTKA Project**

**Field testing of substandard RC buildings:  
*Ambient and forced vibration tests***

**C. Göksu, P. Inci, U. Demir, I. Sarıbas, A.N. Sanver,  
U. Yazgan, A. İlki**

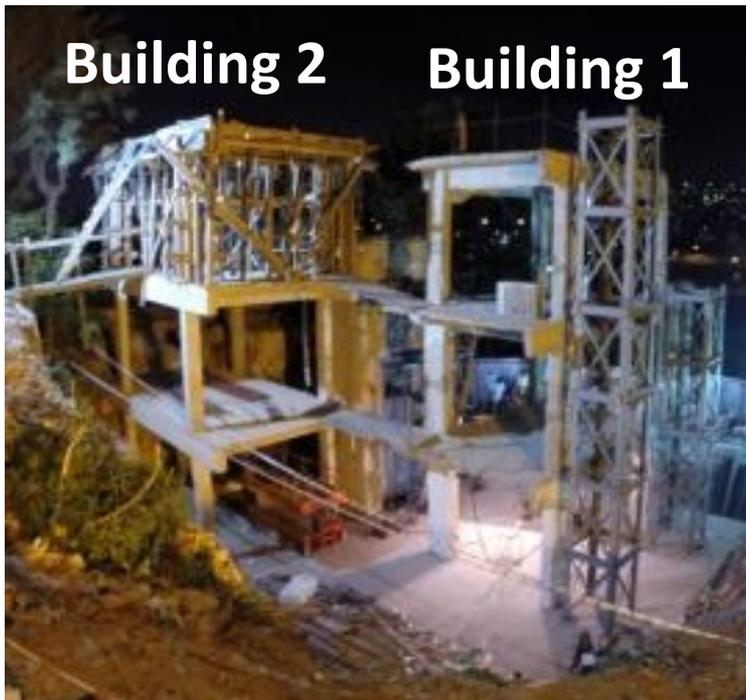
- Reminder of the presentation on the static cyclic test results

## Building 1

Strong column weak beam mechanism  
Normal axial load (i.e. 10%)  
Constructed in early 90s

## Building 2

Weak column strong beam mechanism  
High axial load (i.e. 25%)  
Representative of 70's construction

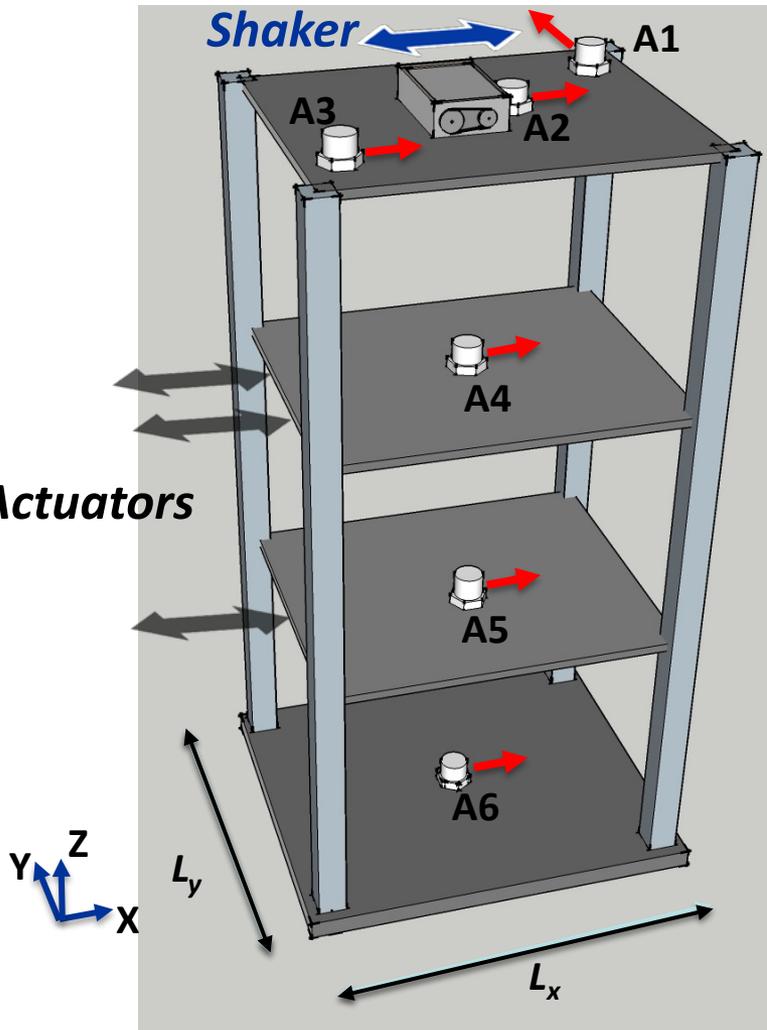
- Accelerometer locations

## Building 1:

## Building 2:

- For performing **Y-direction testing** sensors at the centers of the slabs (i.e. **A2-4-5-6**) were rotated towards Y.

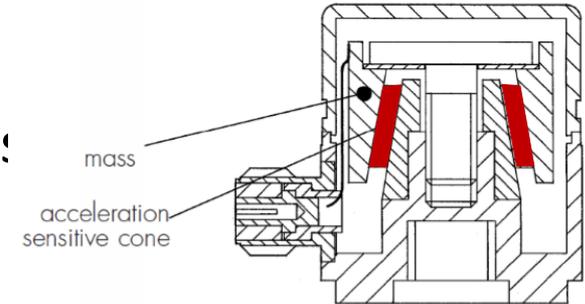
## Piezoelectric accelerometers:

A/1800 IEPE  
by DJB Instruments

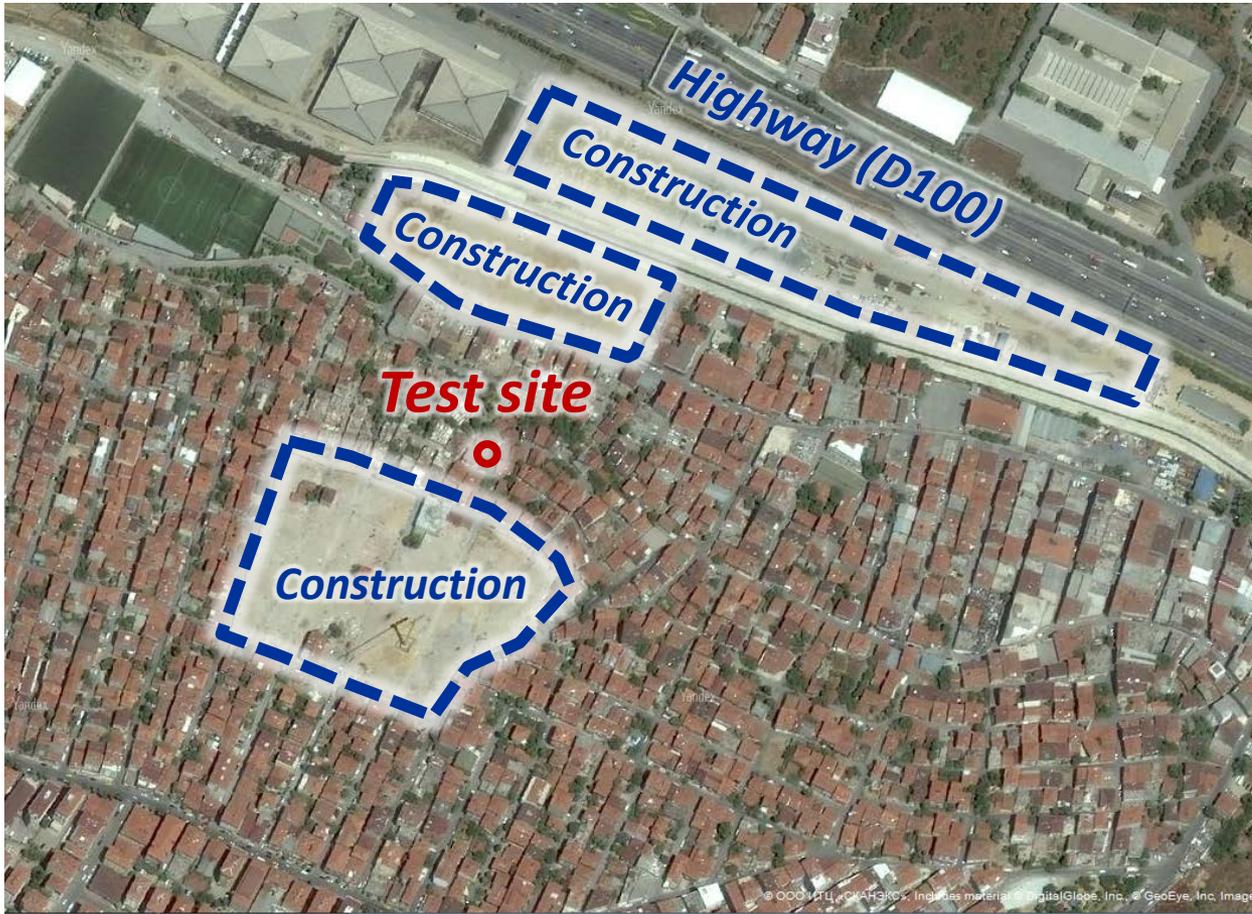
- Ground vibration sources around the site

Construction sites are located around the site. Closest construction site is 50[m] away.

A busy highway is passing approx. 350[m] away from the site

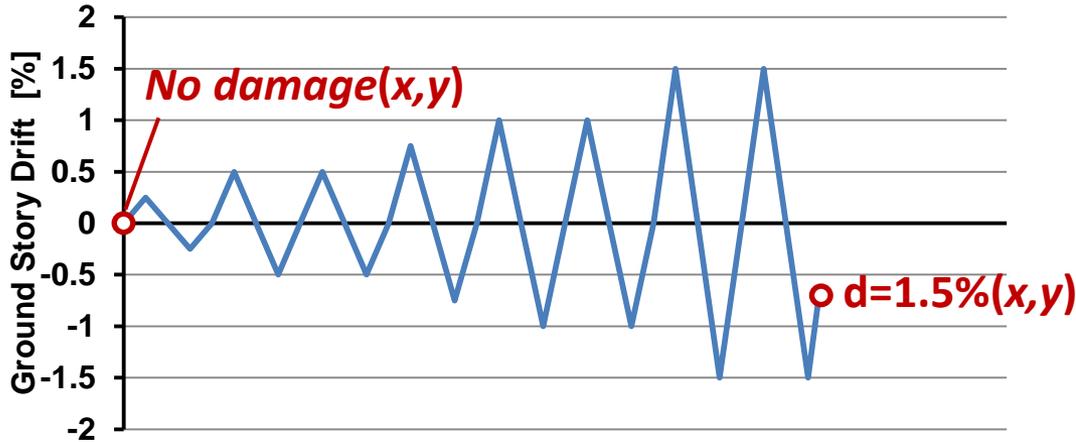
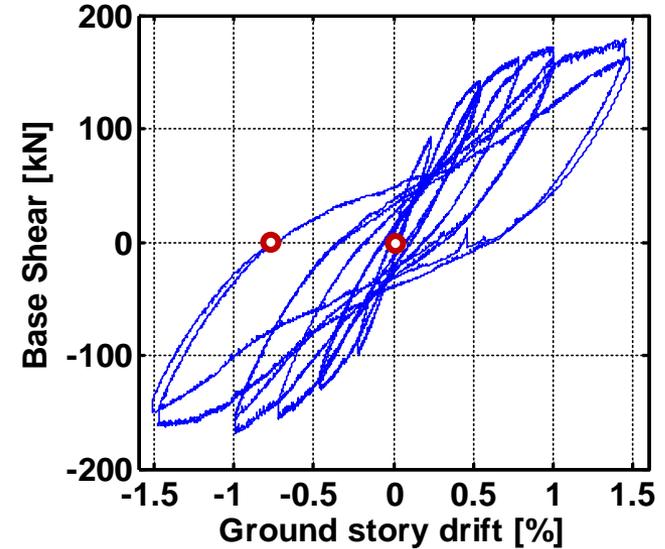
## Building 1

- 4 forced vibration tests

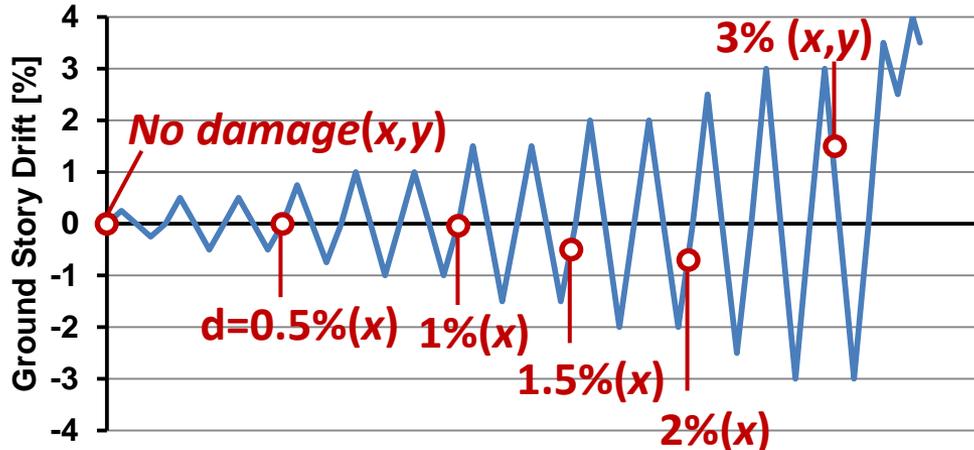
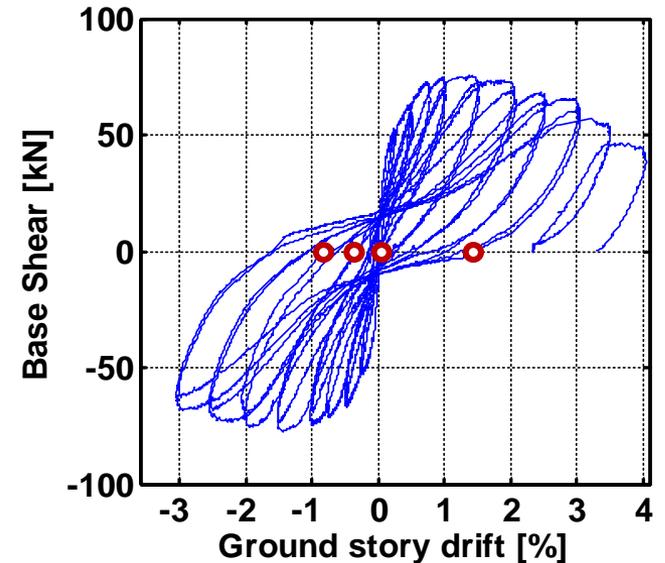
## Building 2

- 8 forced vibration tests

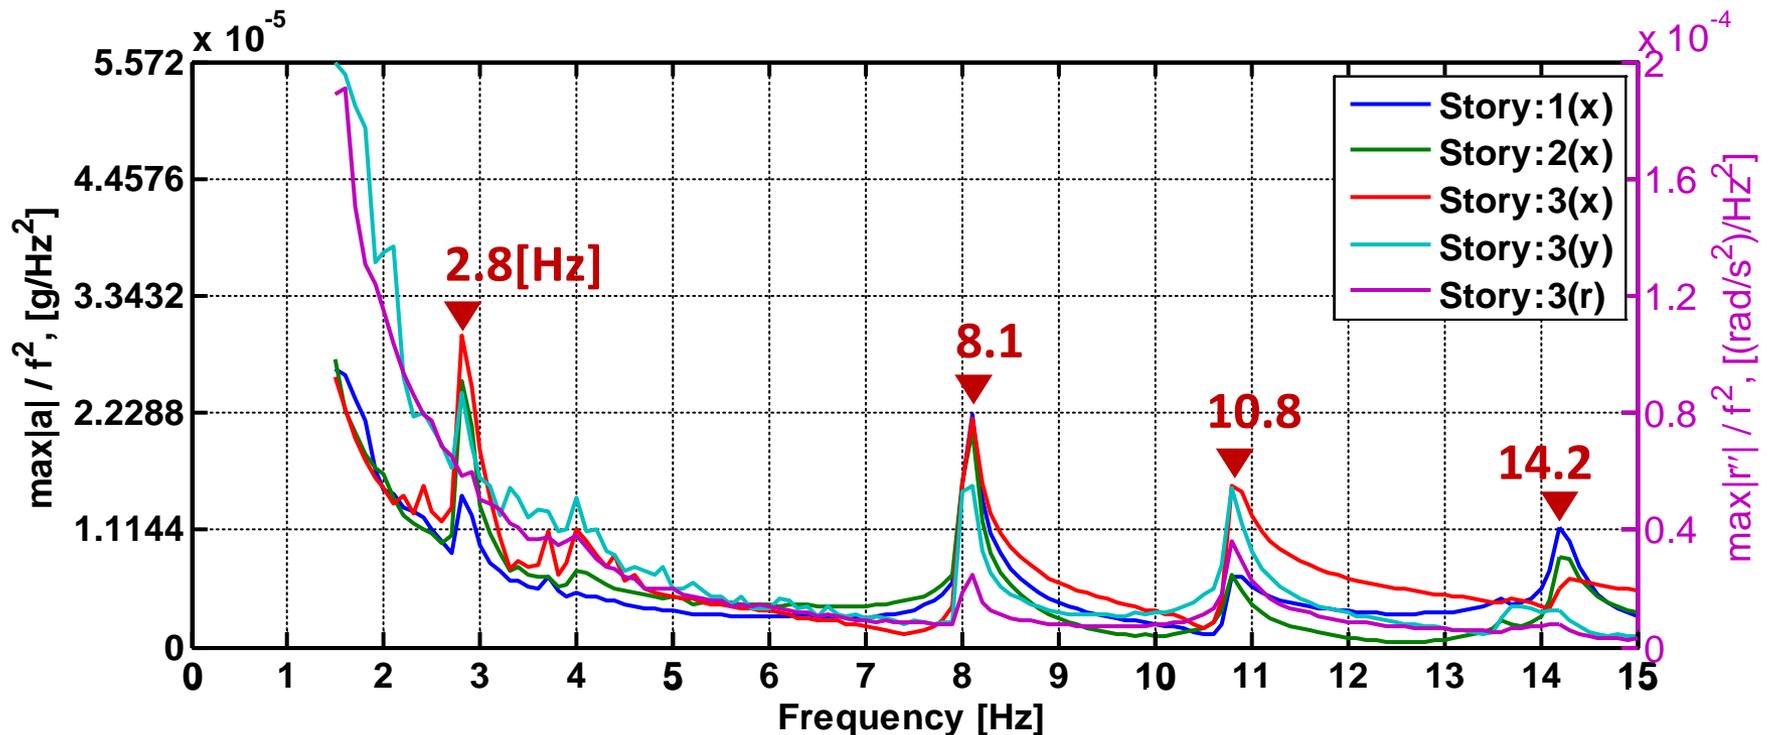
- Building 1, x-direction, no damage

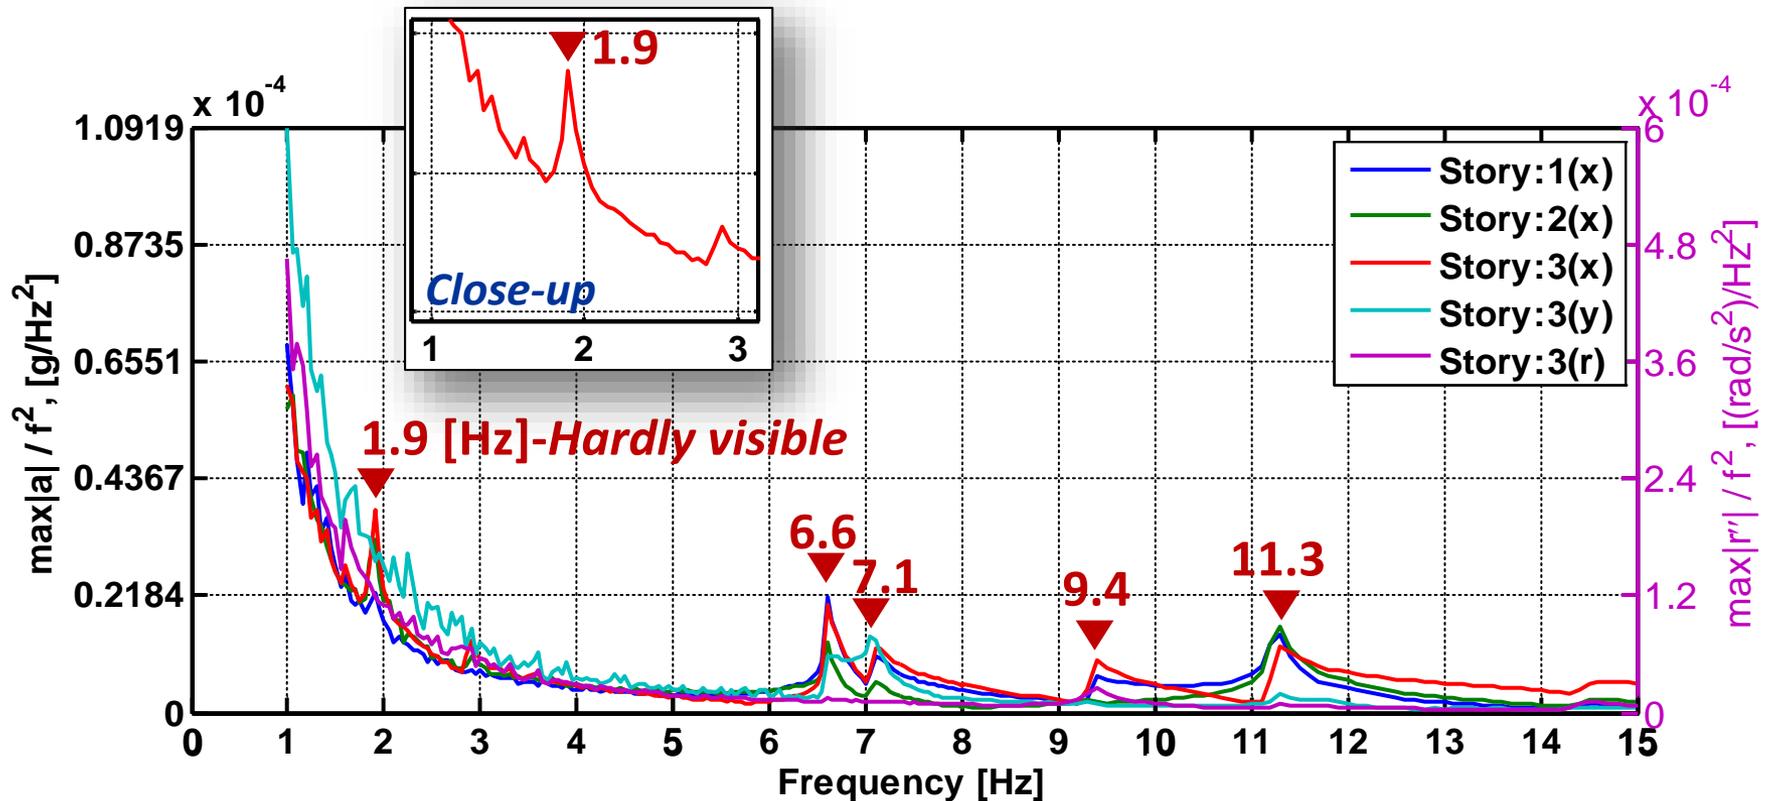
- Building 1, x-direction, d=1.5%

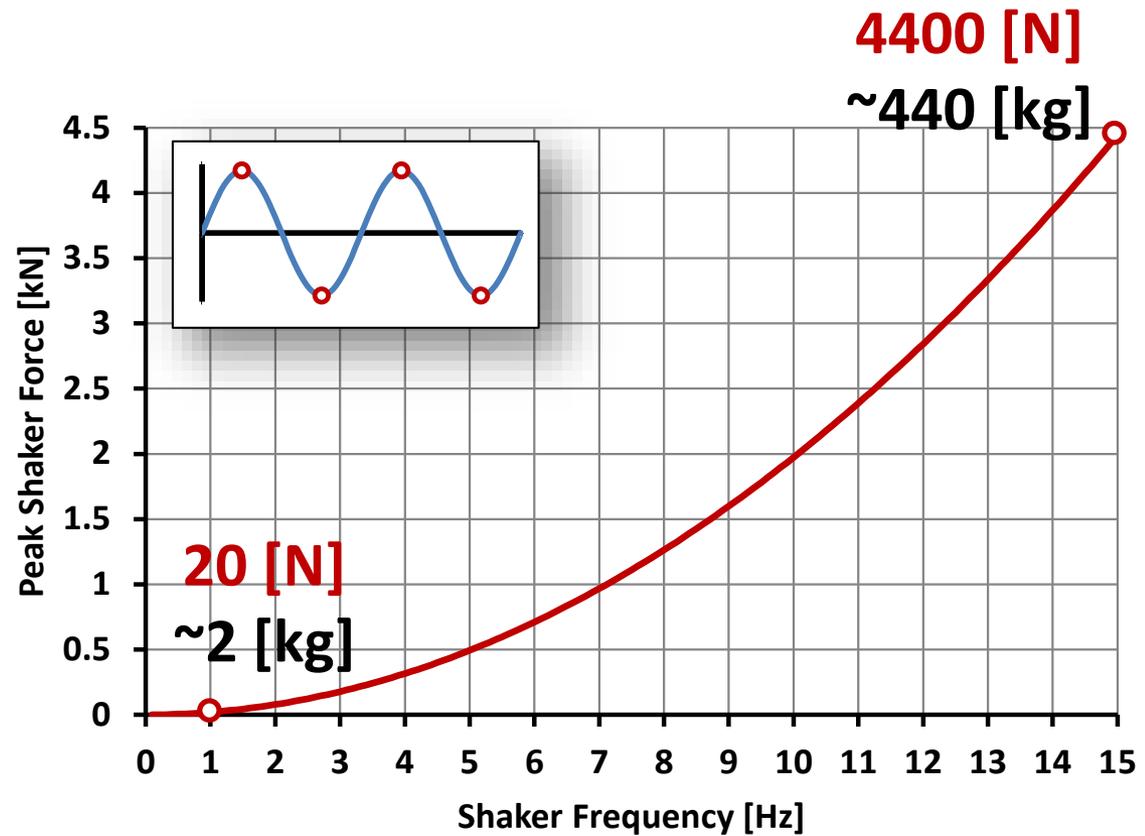
- Peak force at maximum eccentricity

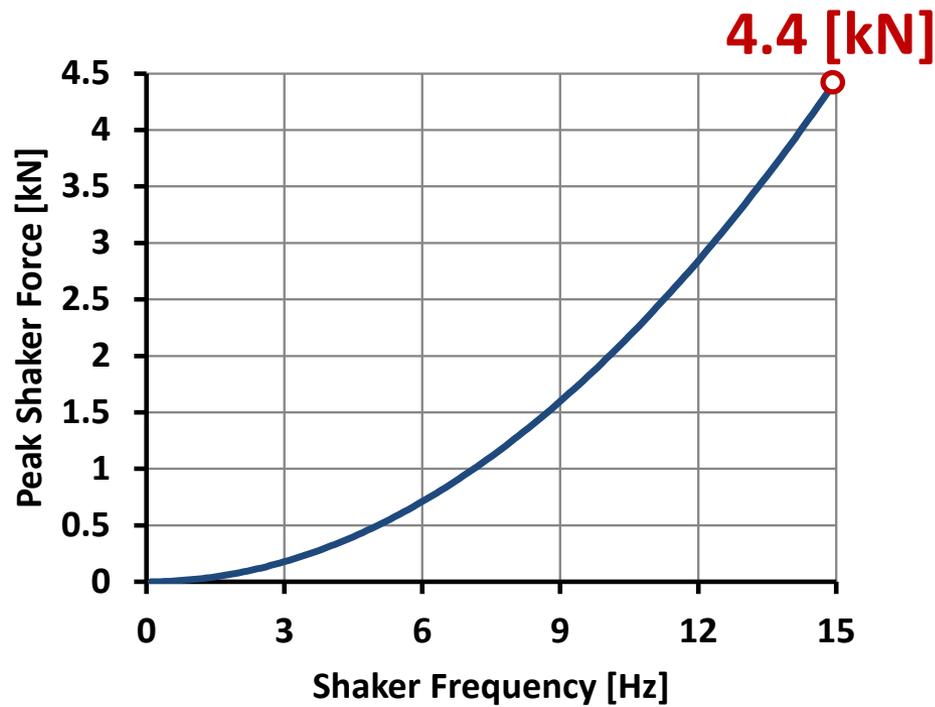
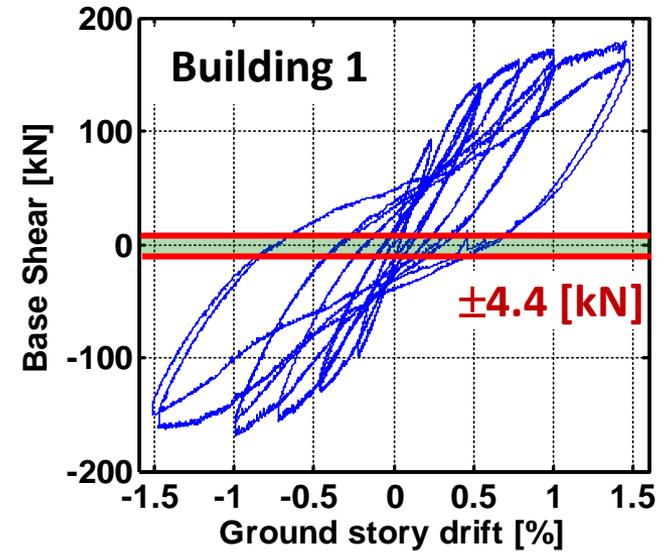
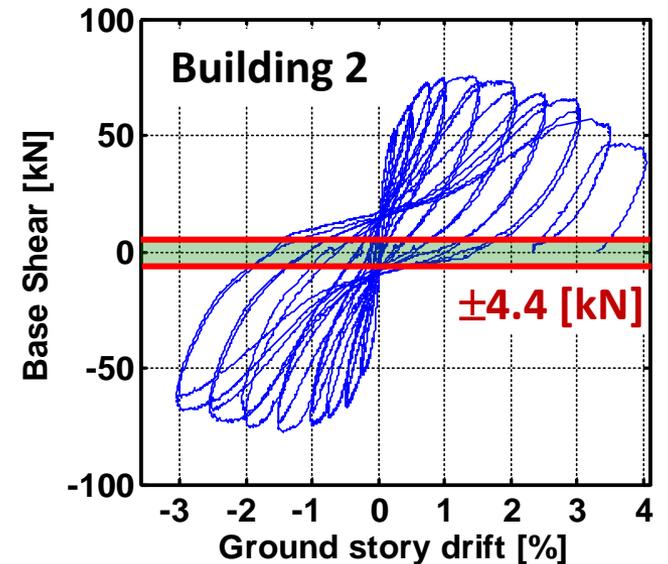
- Risk of large deformations

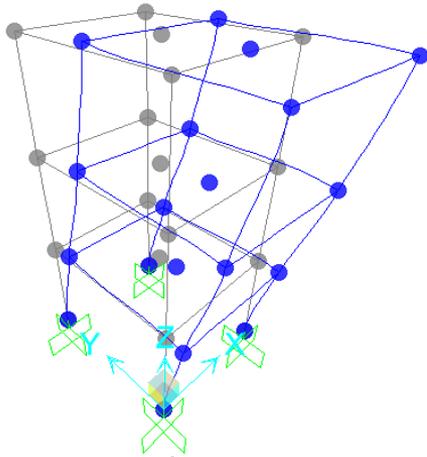
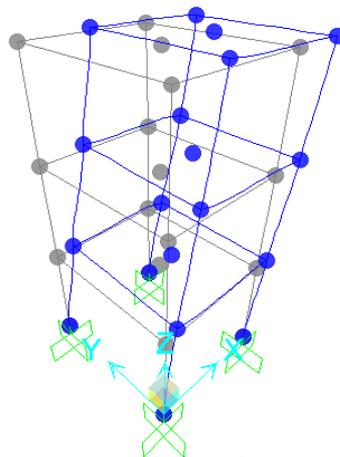
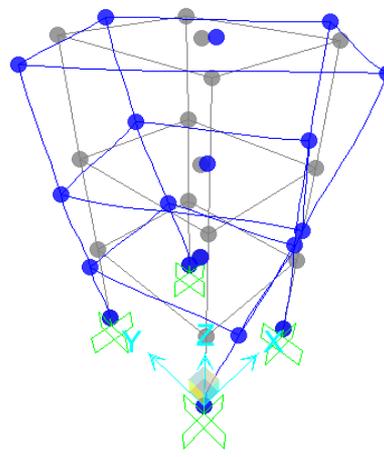
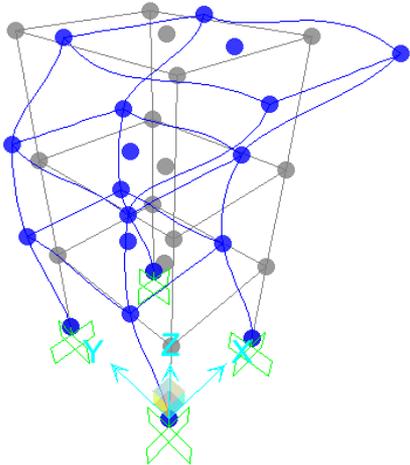
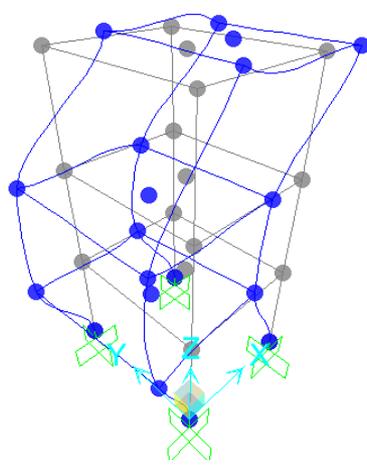
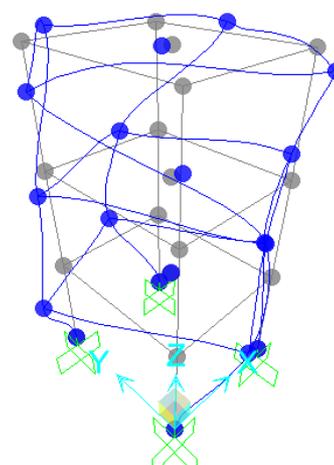
- Building 1

**Mode 1**

**Mode 2**

**Mode 3**

**Mode 4**

**Mode 5**

**Mode 6**

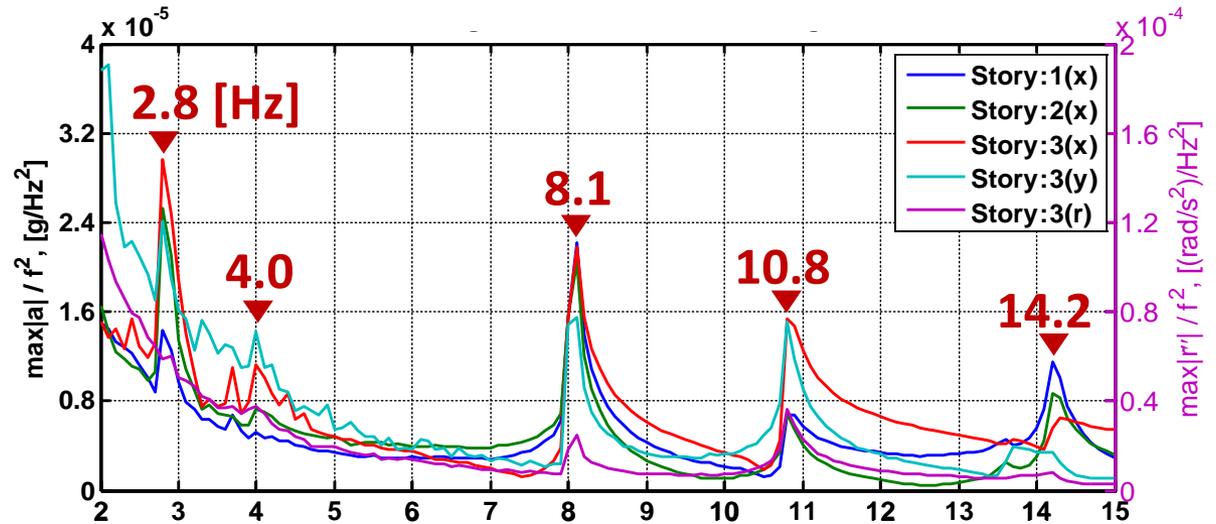
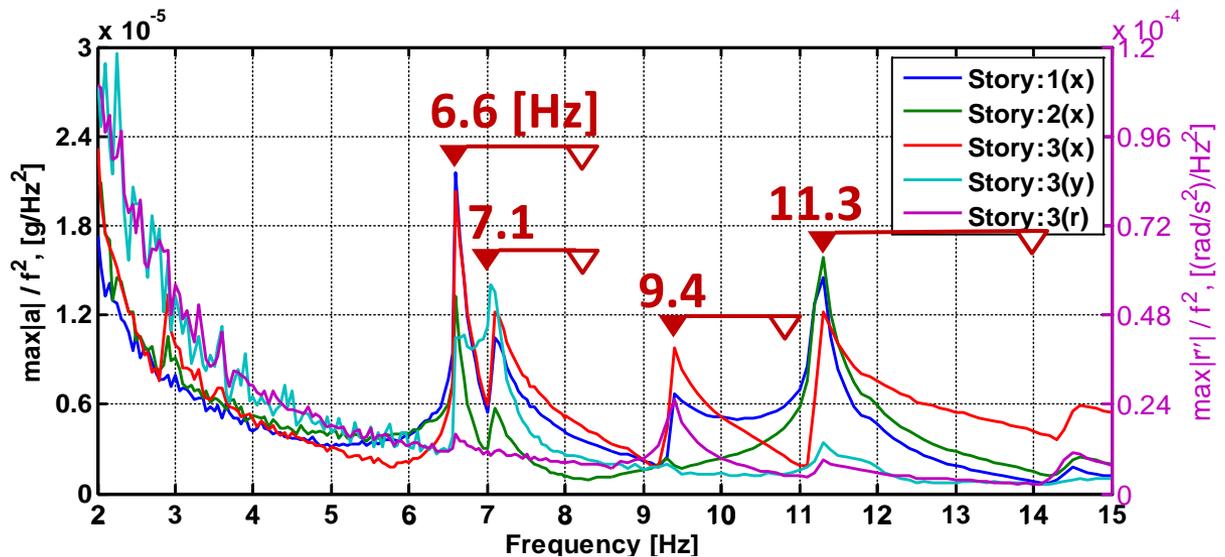
- Building 1, X-direction

No damage

After 1.5% drift

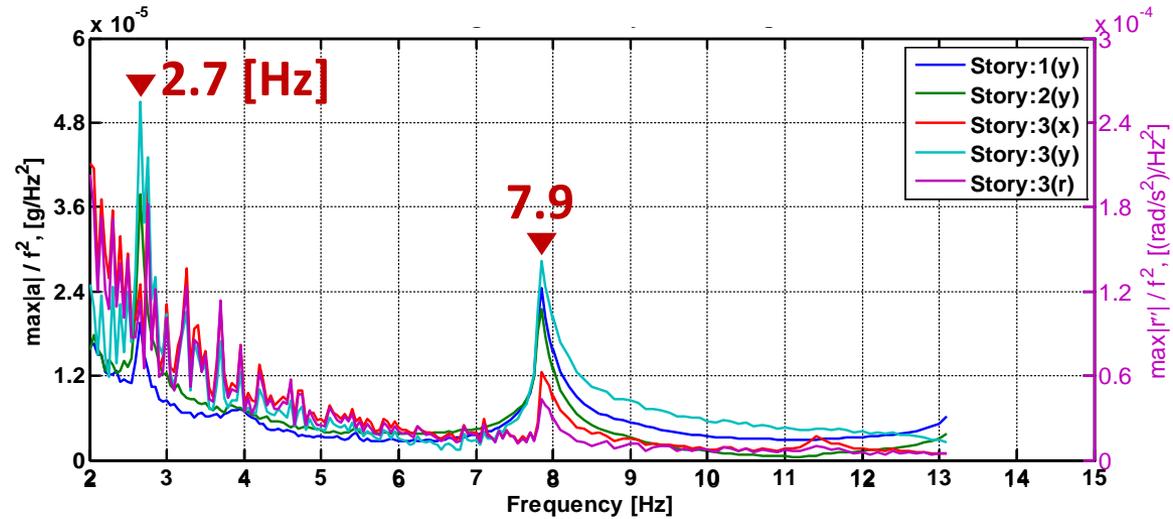
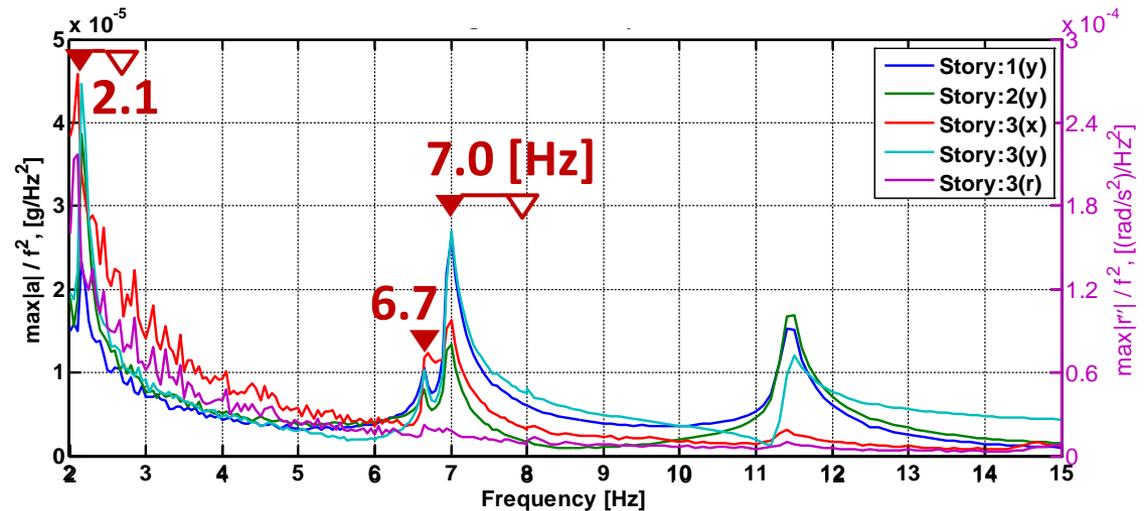
- Building 1, Y-direction

No damage

After 1.5% drift

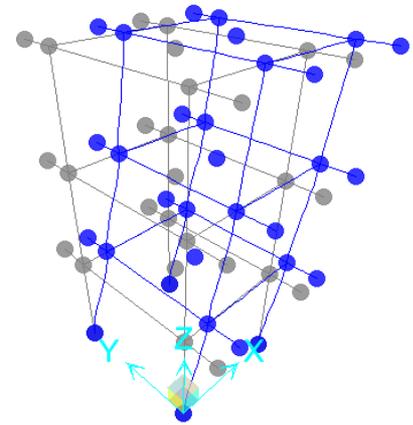
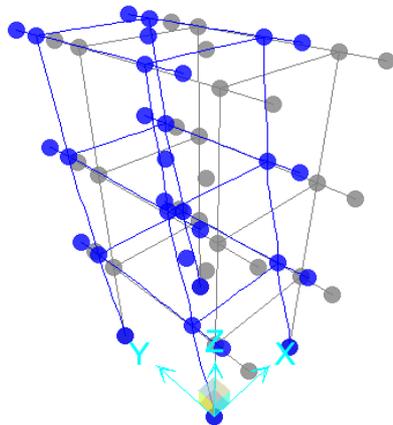
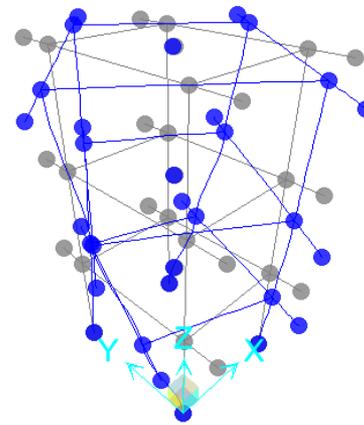
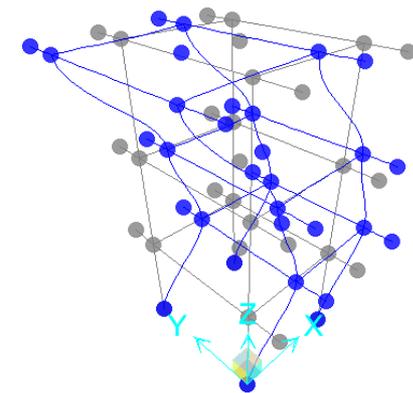
- Estimated Modal Characteristics of Building 2

**Mode 1**

**Mode 2**

**Mode 3**

**Mode 4**

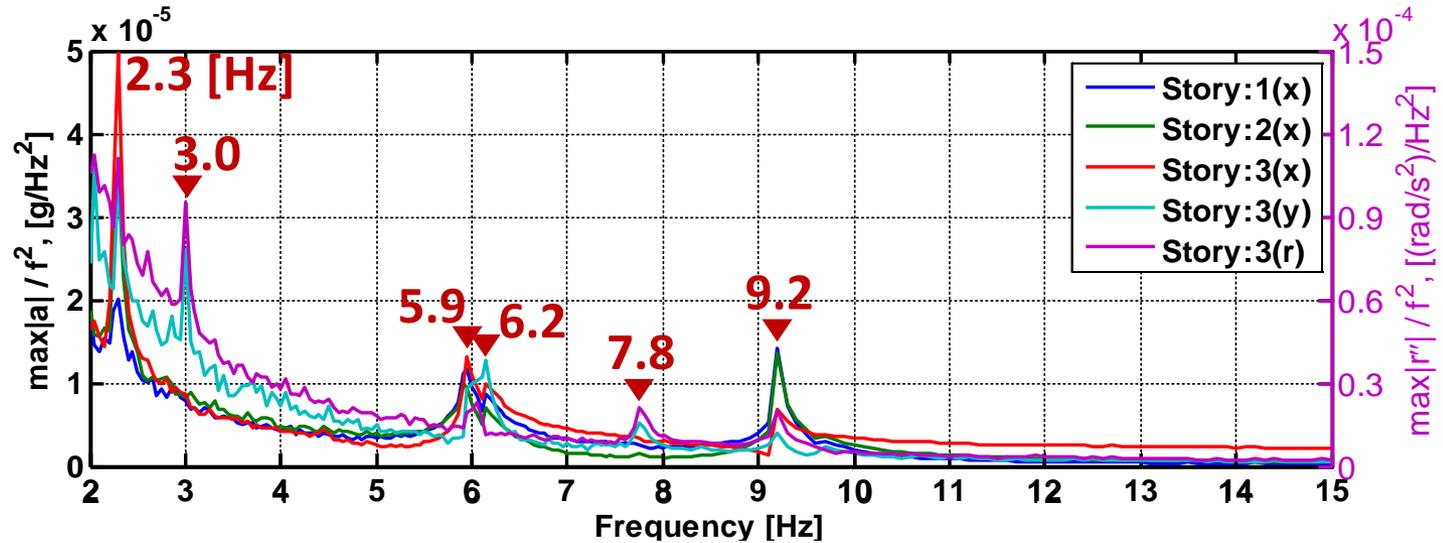
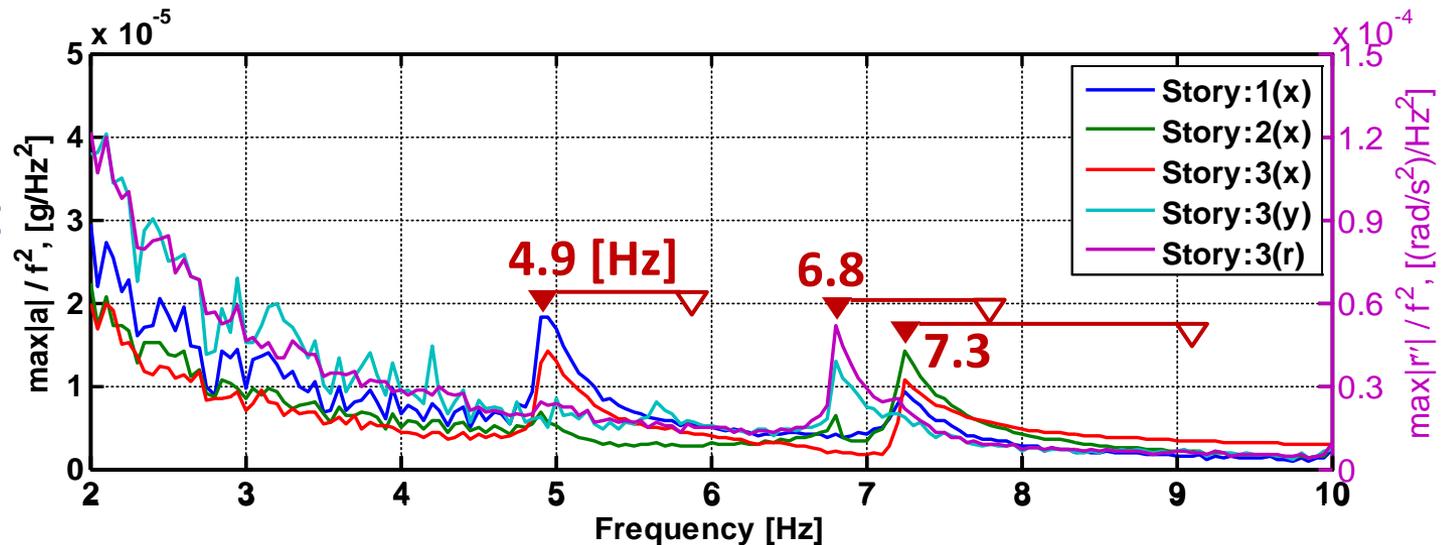
- Building 2, X-direction

No damage

After 0.5% drift

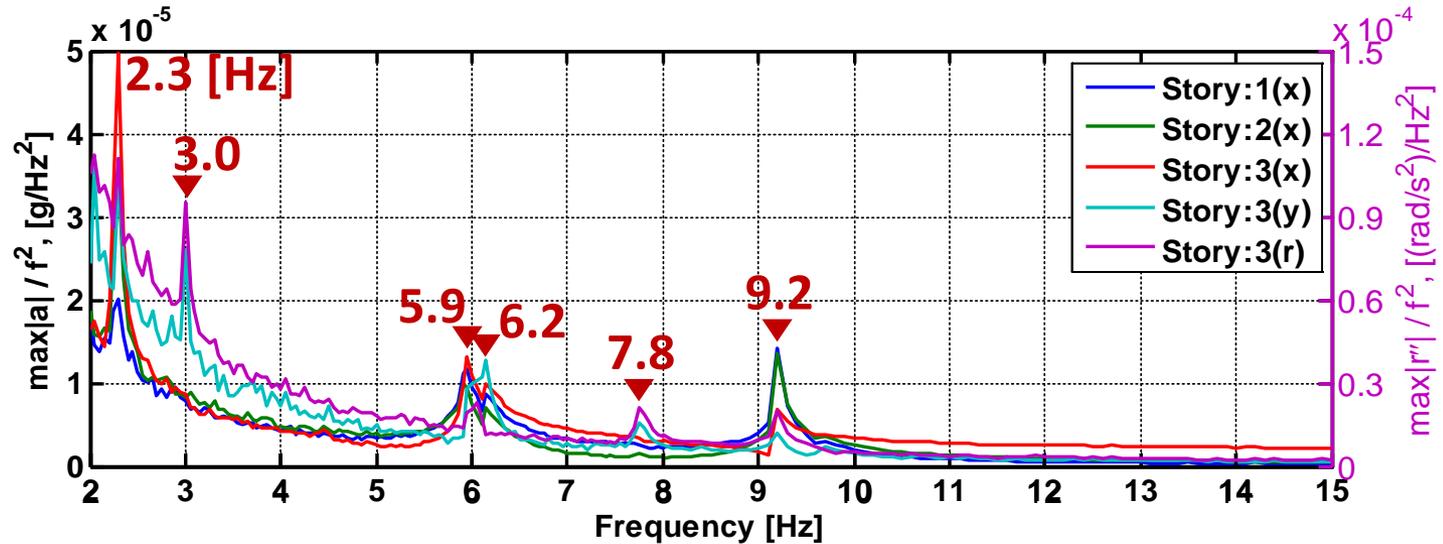
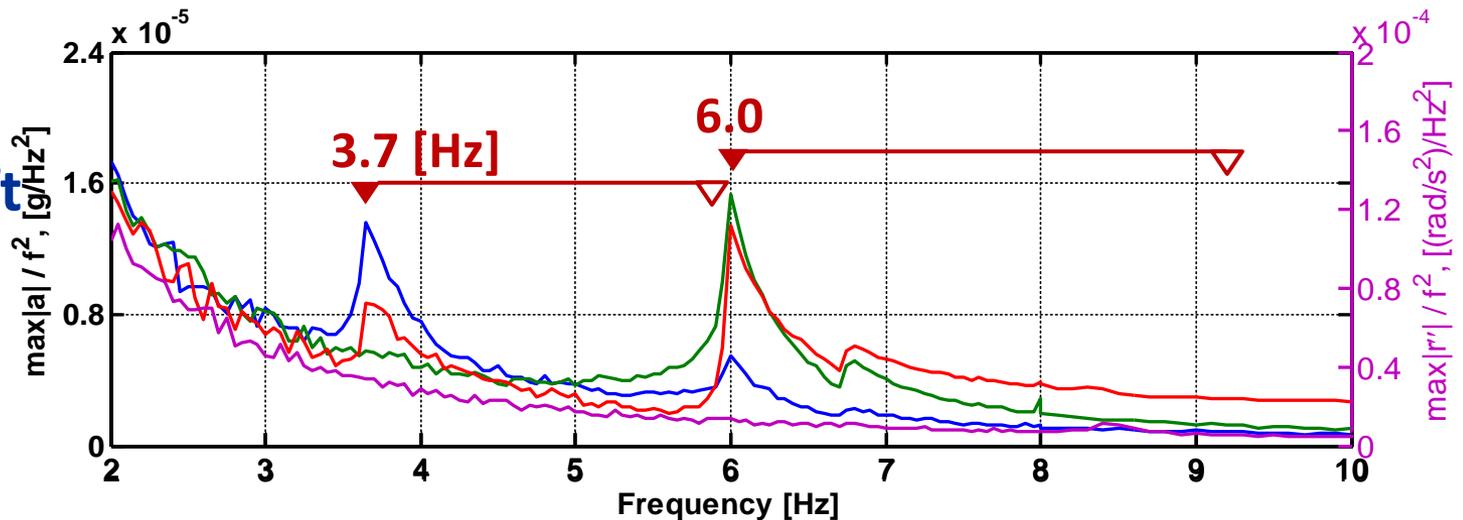
- Building 2, X-direction

No damage

After 3.0% drift

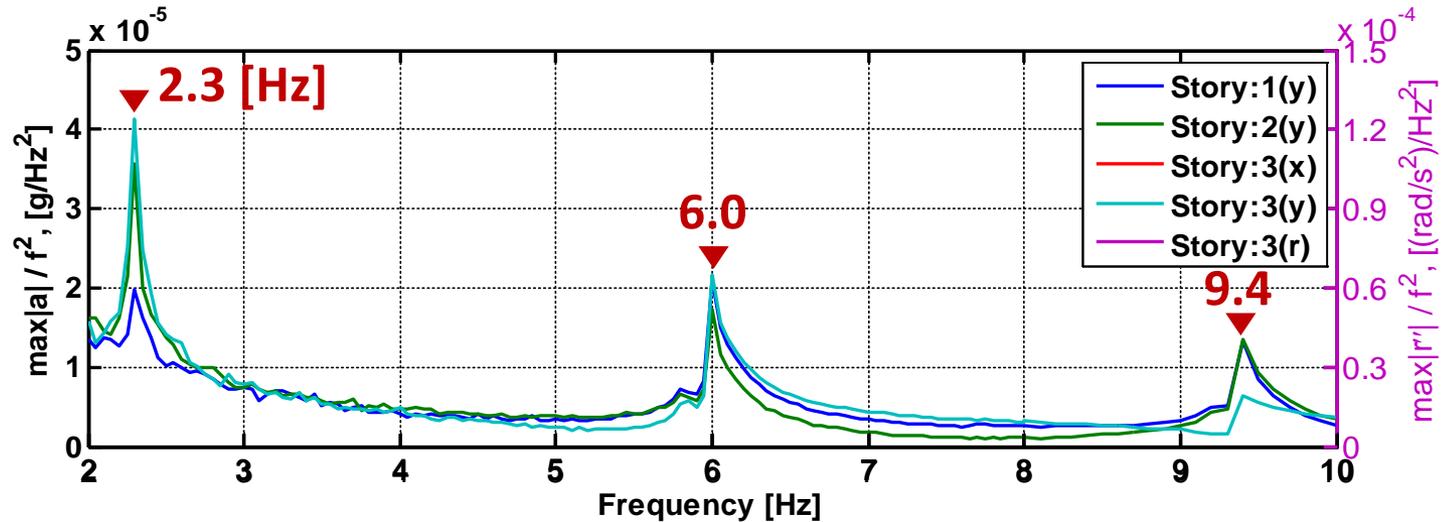
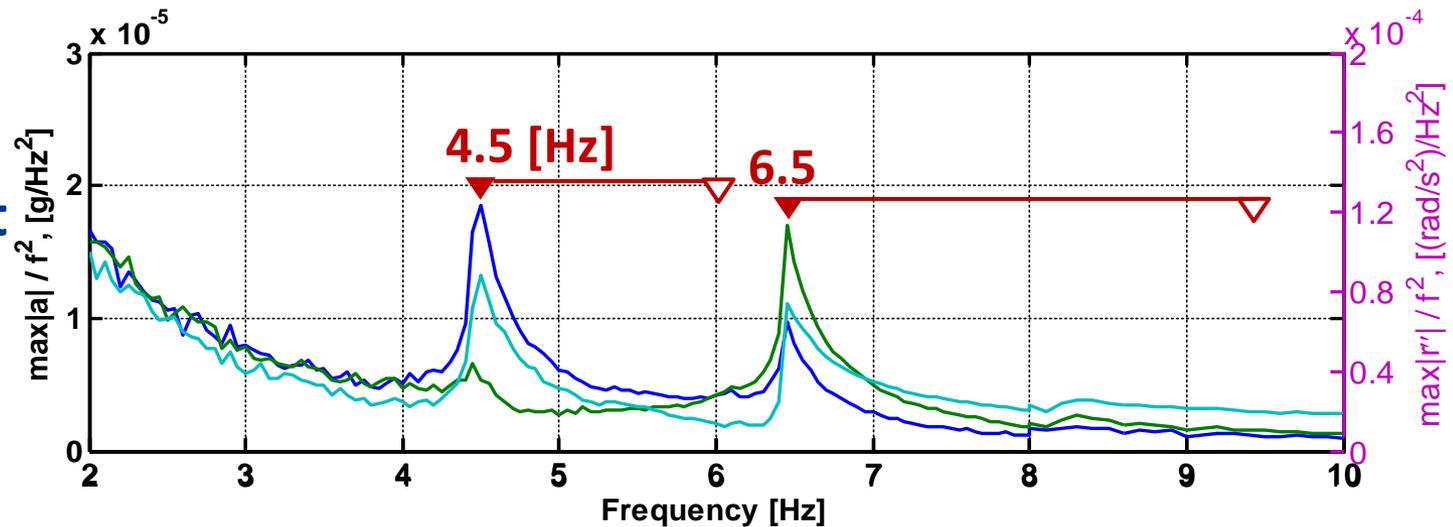
- Building 2, Y-direction

No damage

After 3.0% drift

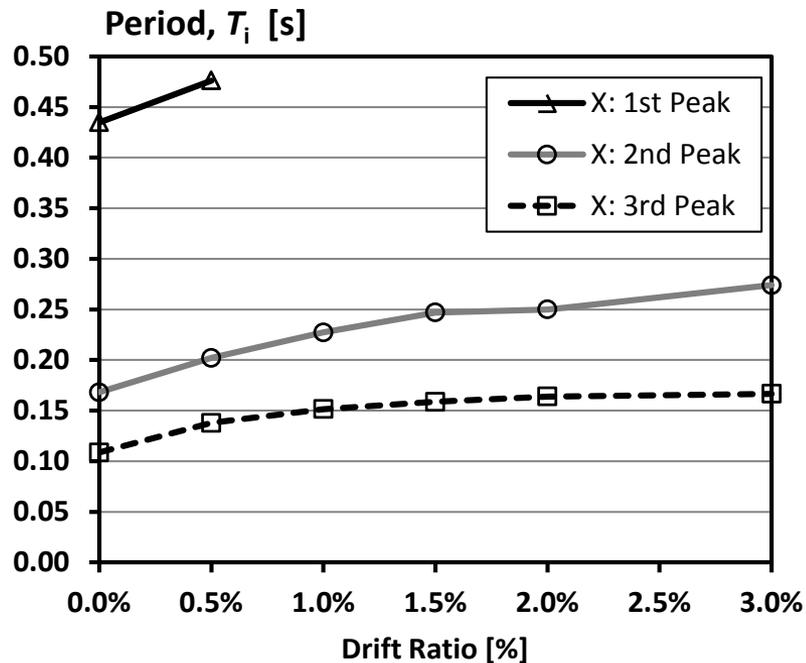
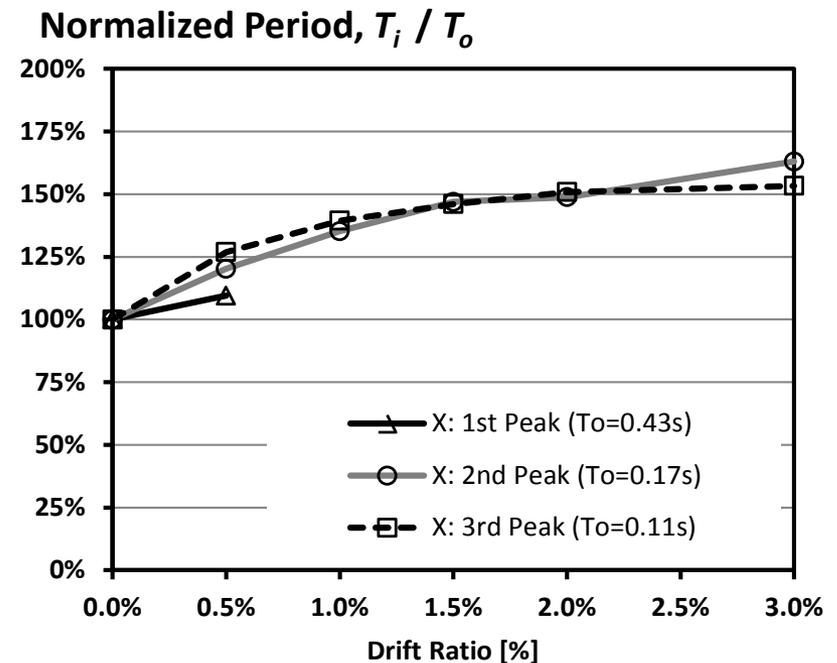
- Building 2: Elongation of modal periods with increasing damage

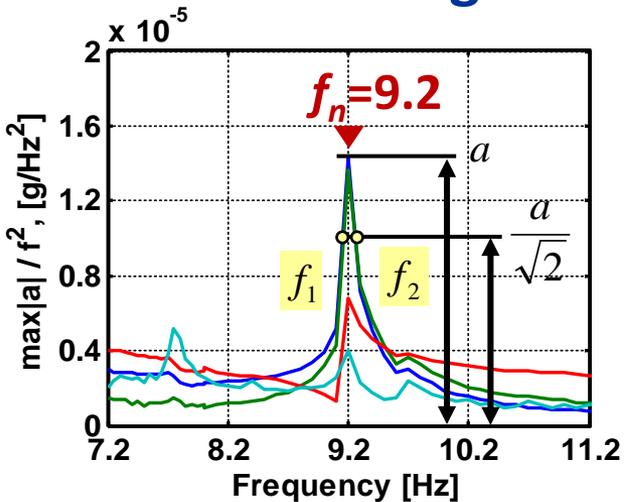
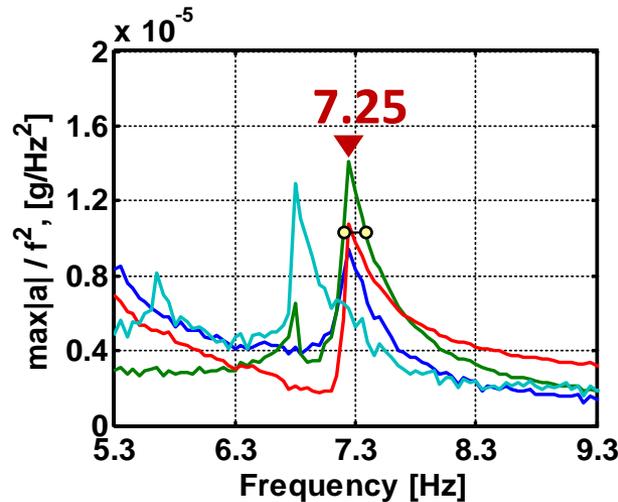
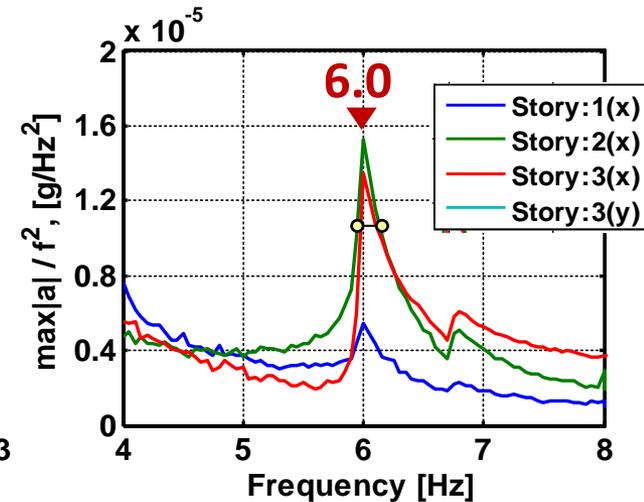
- Identification of Damping using Half Power Bandwidth Method

### No damage

### After 0.5% drift

### After 3.0% drift

$$\zeta = \frac{f_2 - f_1}{2f_n} *$$

$\zeta = 0.6\%$

$\zeta = 1.4\%$

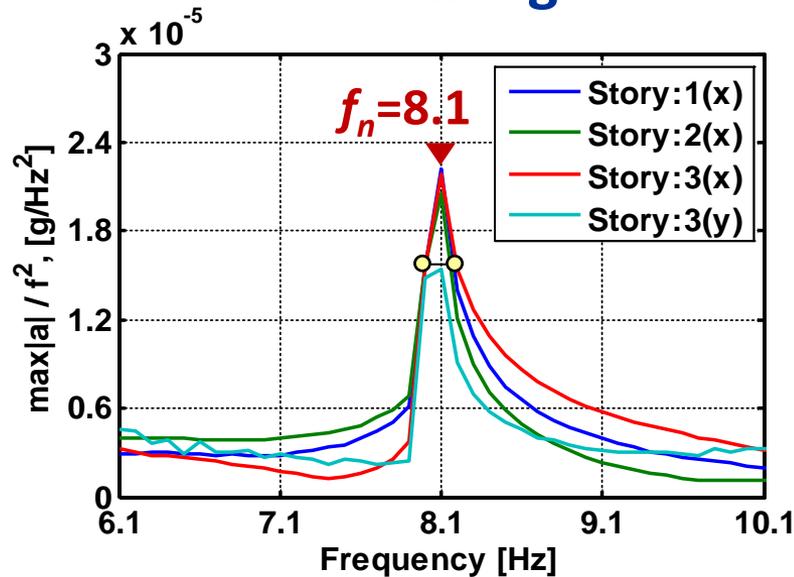
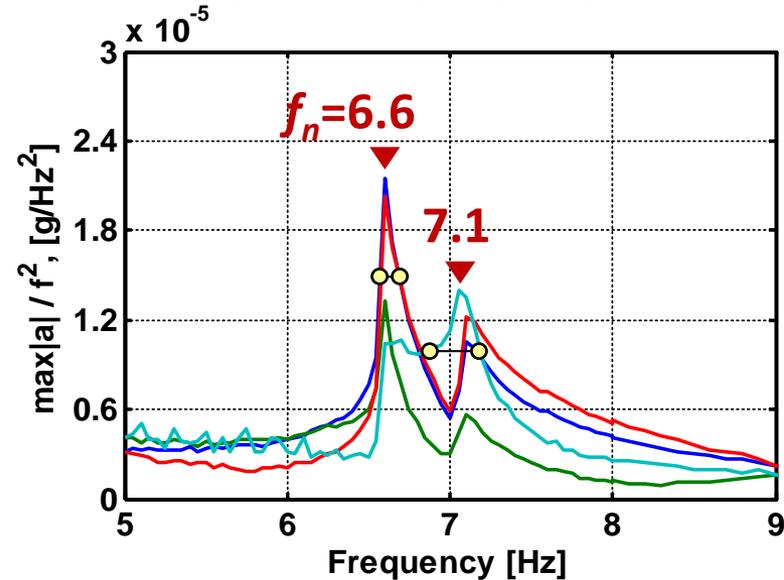
- Issues related to damping when the peaks are coincident:  
(Building 1)

No damage

$\zeta = 1.3\%$

After 1.5% drift

$\zeta = 1.1\%$

$\zeta = 2.6\%$

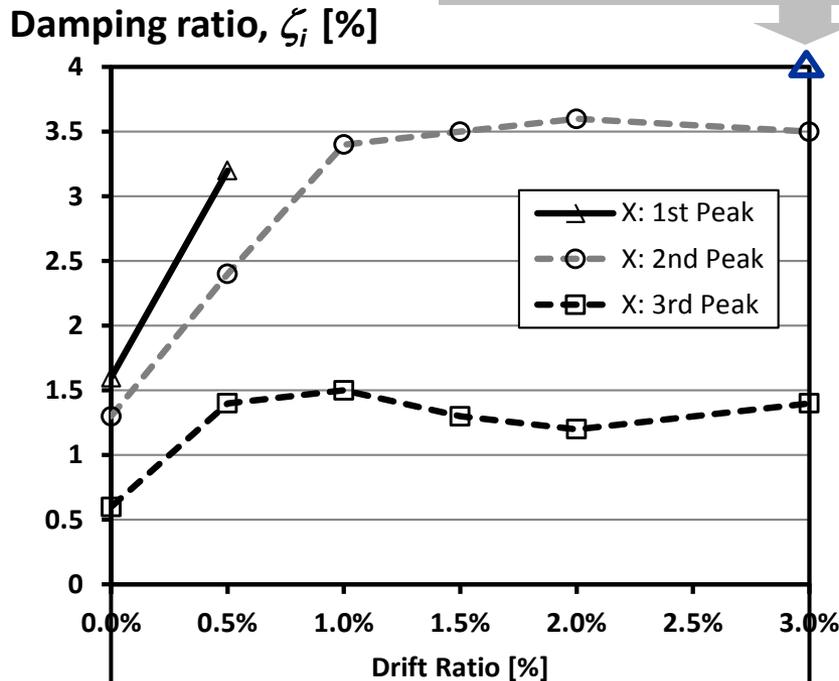
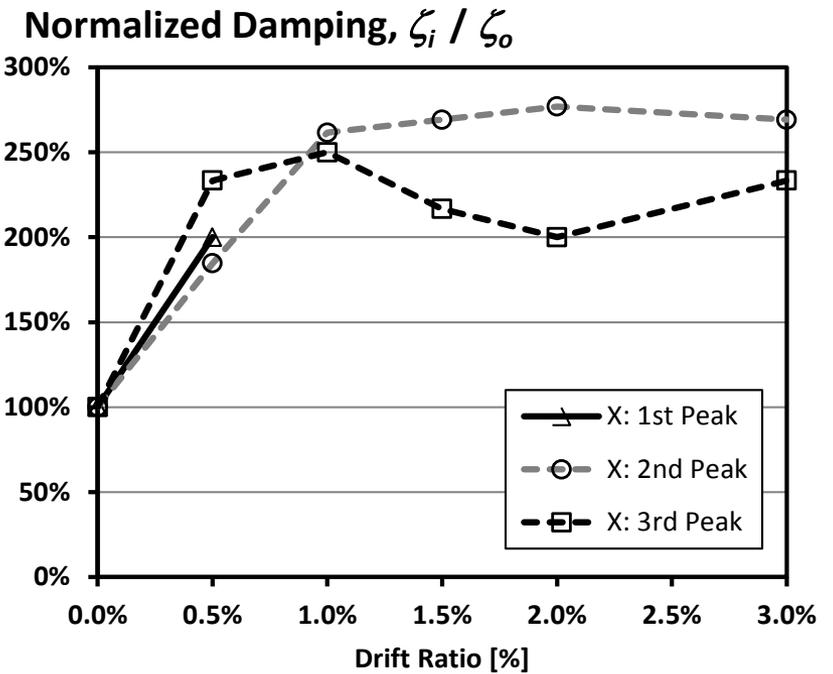
- Building 2, X-Direction

Extrapolated:  
 $2.5 \times (1.6\%) = 4\%$

Operational  
 Im. Occupa.  
 Life safety  
 Near collapse
