**Workshop on "Determination of the Seismic Performance of the Existing Buildings by Full Scale Tests" October 20<sup>nd</sup>, 2014, Istanbul – ISTKA Project**

**Field testing of substandard RC buildings:  
*Ambient and forced vibration tests***

**C. Göksu, P. Inci, U. Demir, I. Sarıbas, A.N. Sanver,  
U. Yazgan, A. İlki**

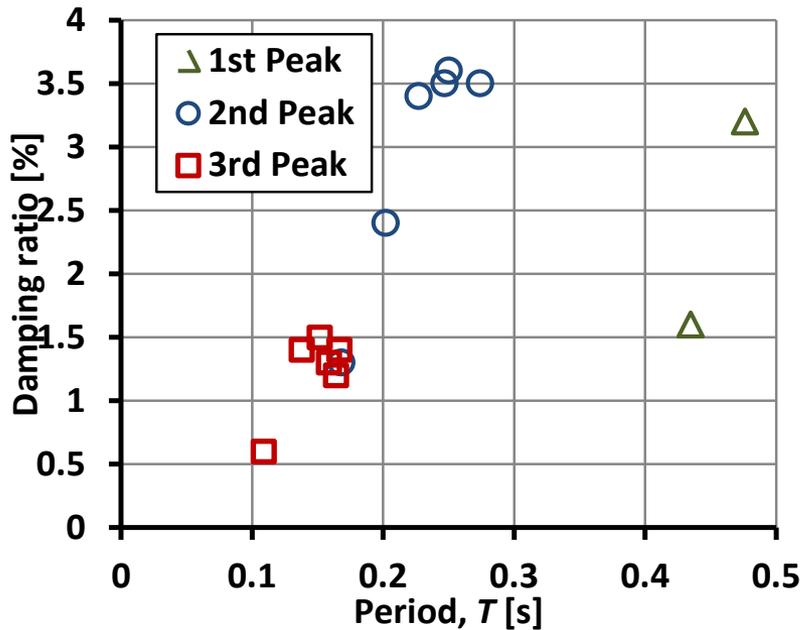
- Building 2, X-Direction

## Observed Response

- *Very limited observation set*
- *No soil flexibility*
- *No non-structural elements*

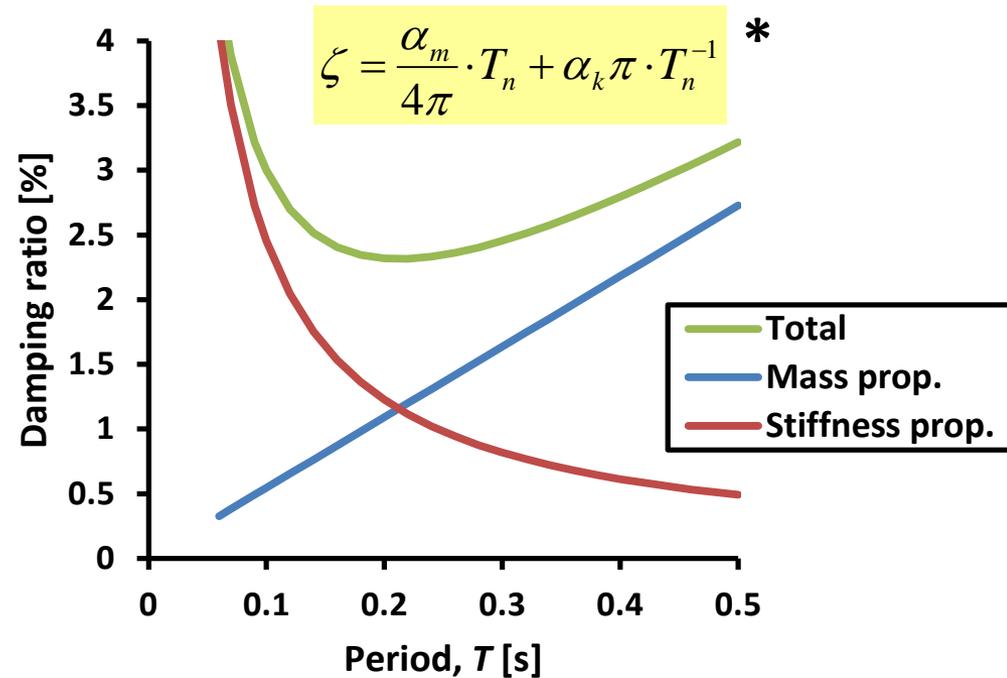
## Conventional Model

Rayleigh Damping:  $[C] = \alpha_m [M] + \alpha_k [K]$

*"Extended Rayleigh Damping (with multiple constraints)" or similar models may be more suitable.*

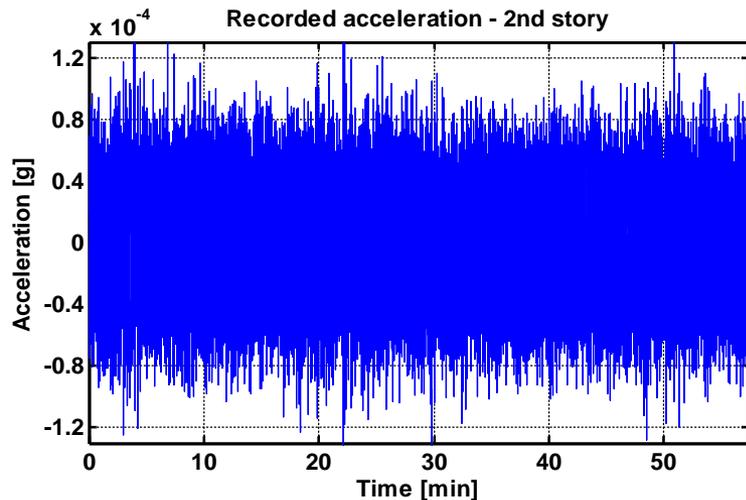
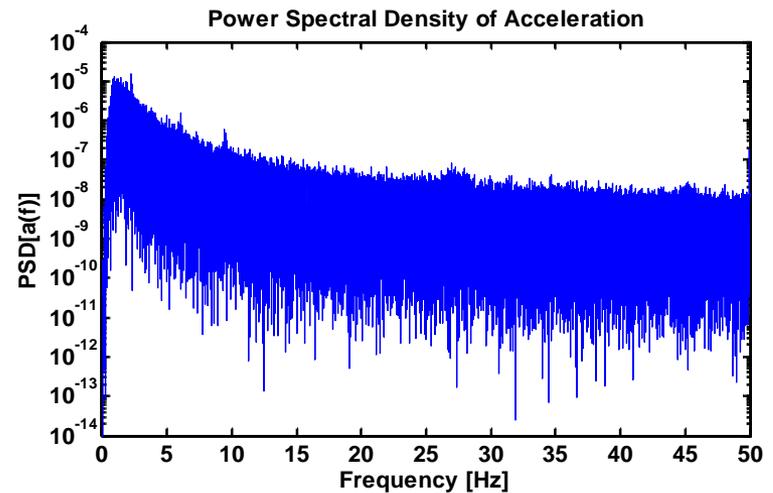
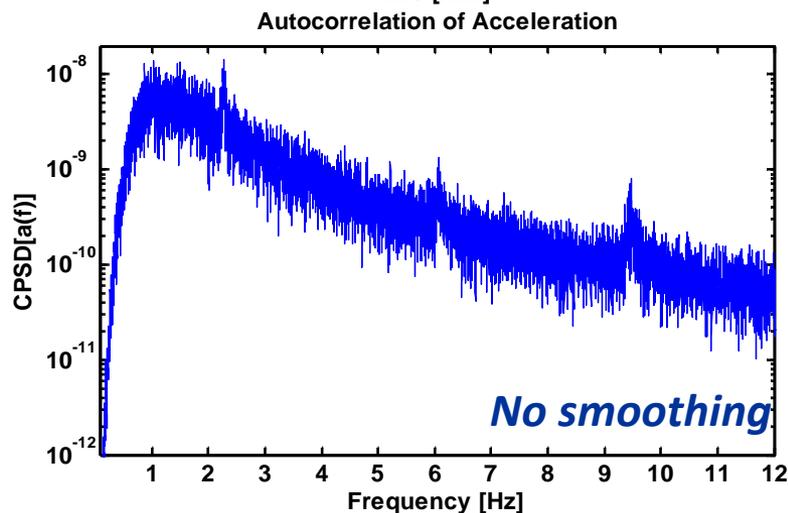
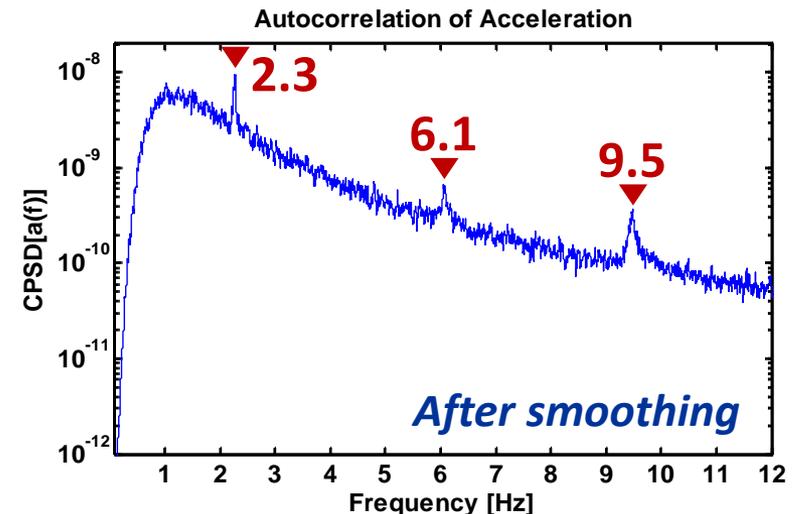
- Ambient vibrations were measured (when the time allowed)

## Example: Building 2, X-Direction, No Damage

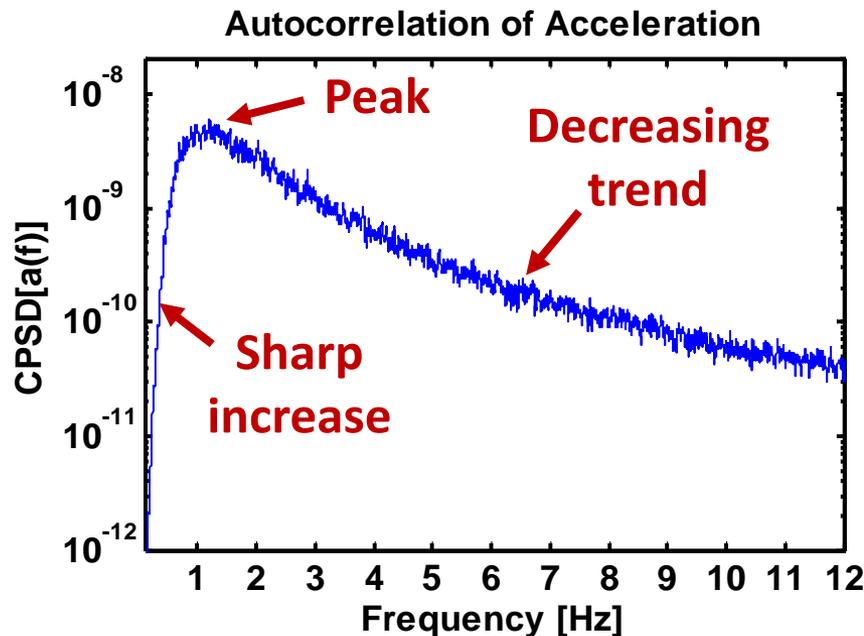
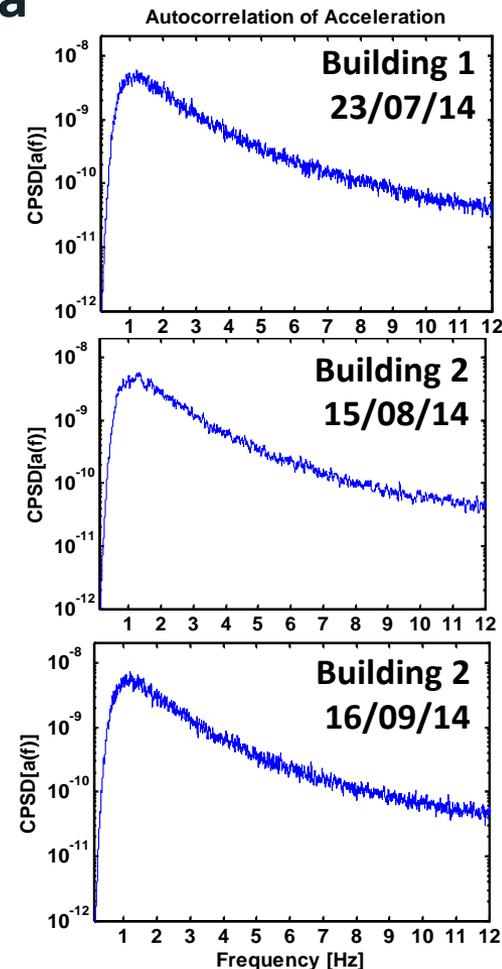
- Issues related to the shape of resulting spectra

Example: Case for sensor at the foundation (which is expected to provide a flat spectrum).

Considered causes:

- Sensor limitation
- Cabling limitation
- Connection to data logger
- *Other?*

● *All have the same trend*

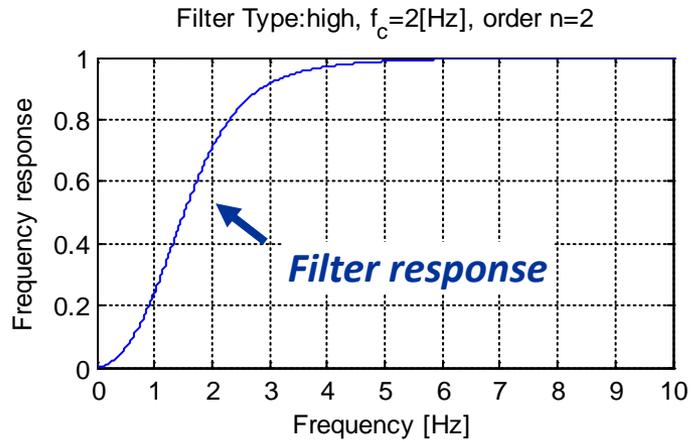
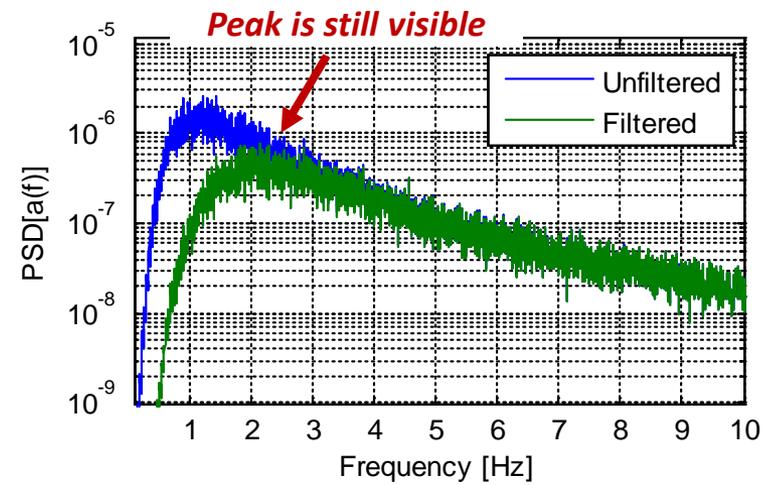
**Trial 1**

- Simple filtering did not solve the issue

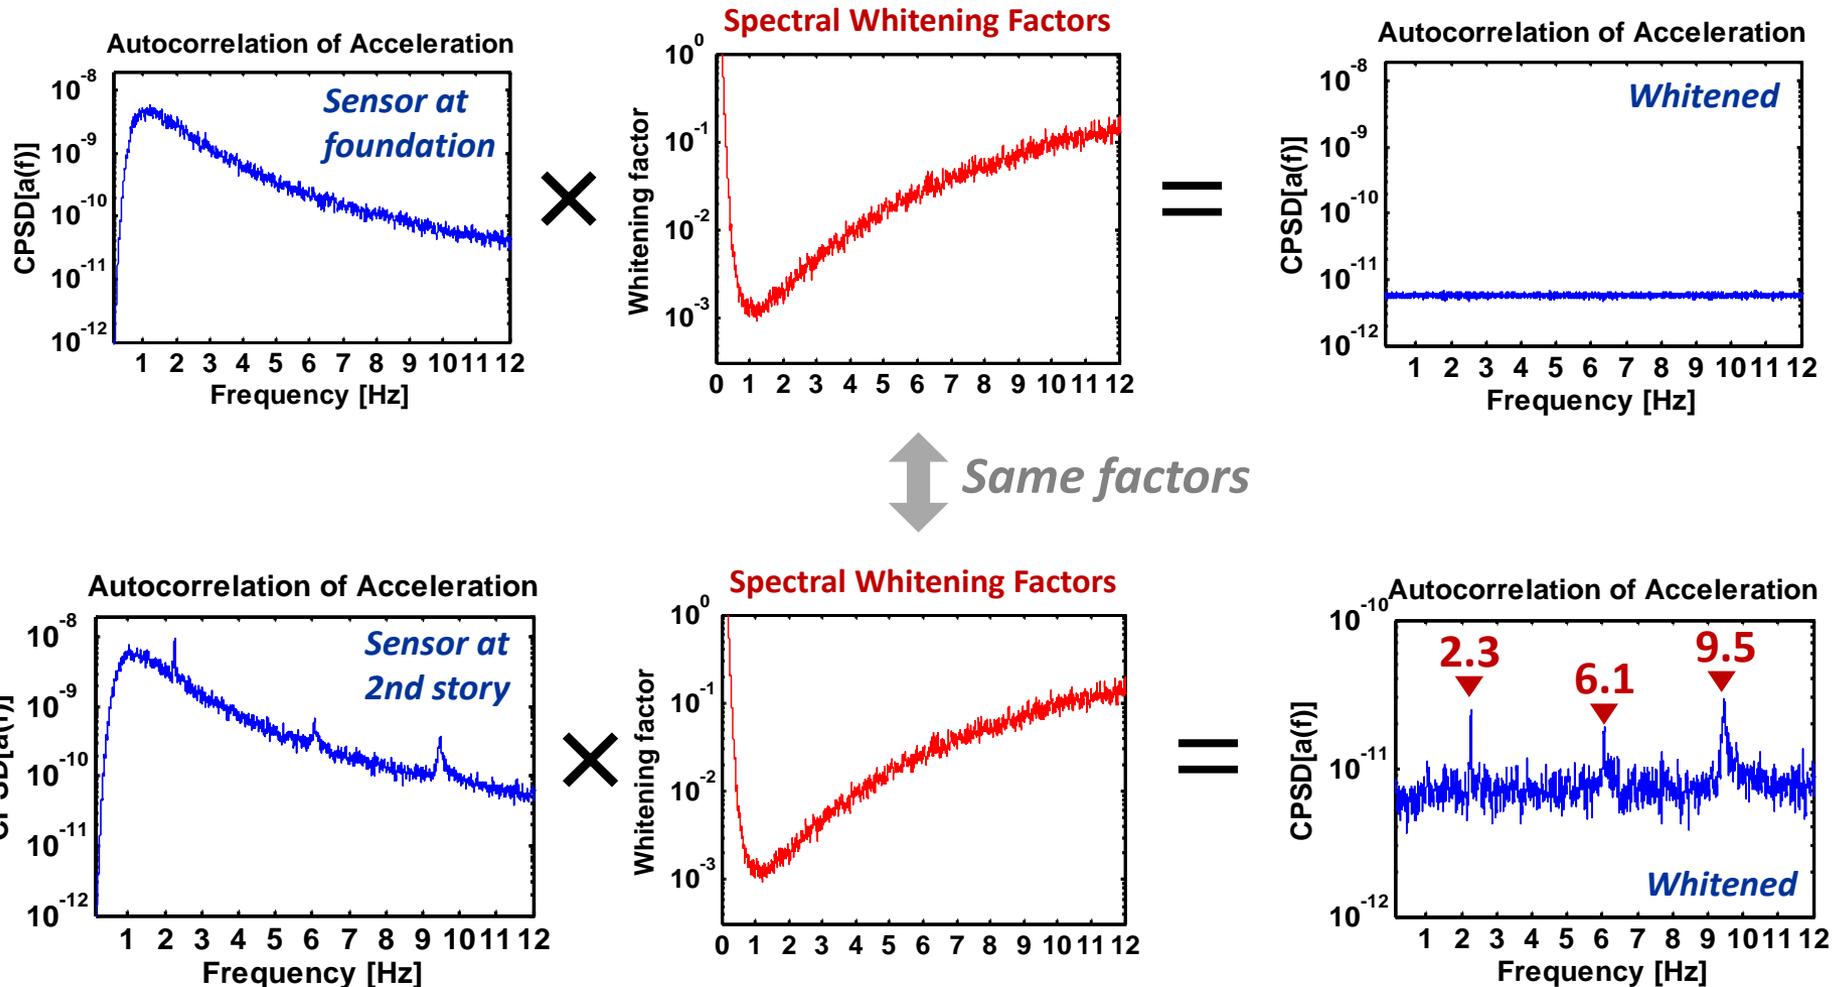
- Application of "spectral whitening"

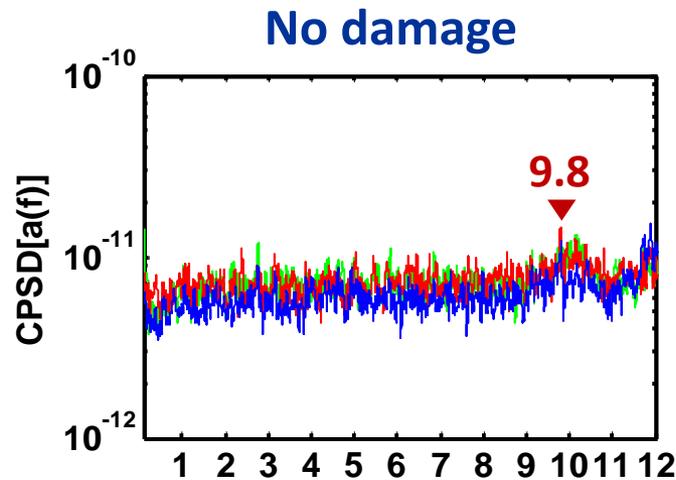
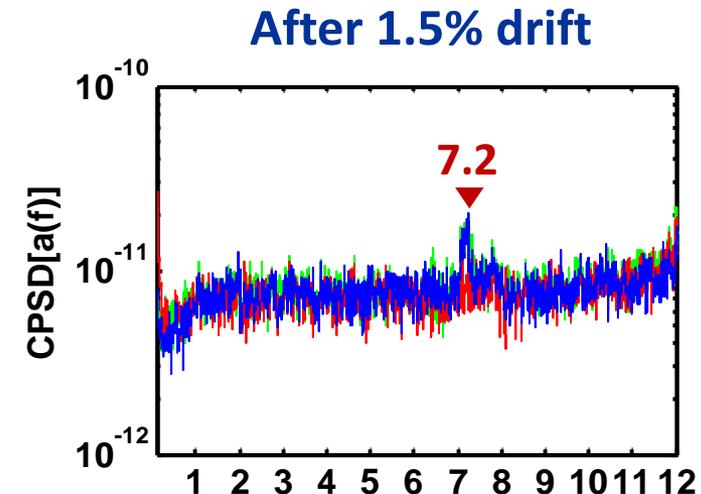
Building  
1

- Resulting "whitened" ambient vibration spectra
